Inspection Report

Property Address:
1234 Main Street
Anytown IL 60554

Quality Assurance Home Inspections, Inc.

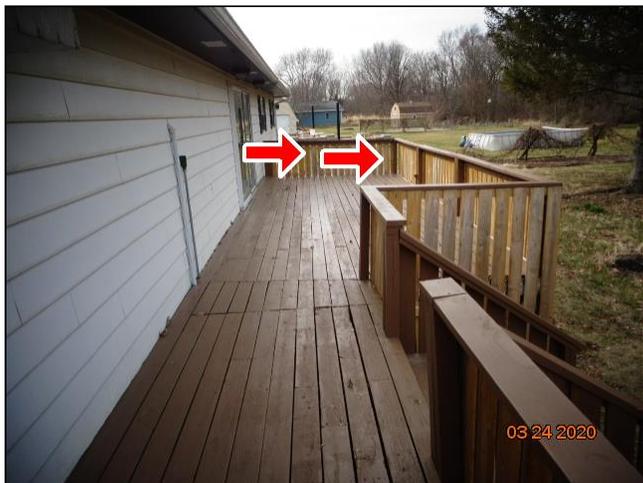
1.3 Item 1(Picture)

1.3 (2) Deck structure was not level/square, recommend proper repairs.

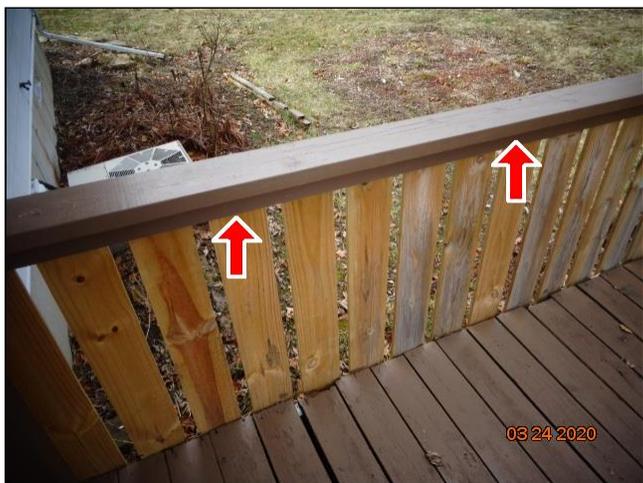
1.3 Item 2(Picture)

1.3 (3) Deck railings were loose and need to be secured; potential safety hazard, recommend proper repairs.

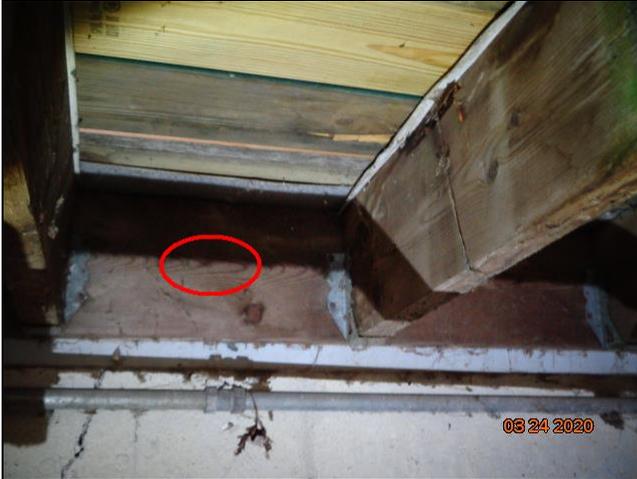
1.3 Item 4(Picture)

✘ 1.3 (4) Deck (ledger board) is not attached to the house properly, recommend lag bolts are installed to properly secure the Deck, recommend proper repairs.

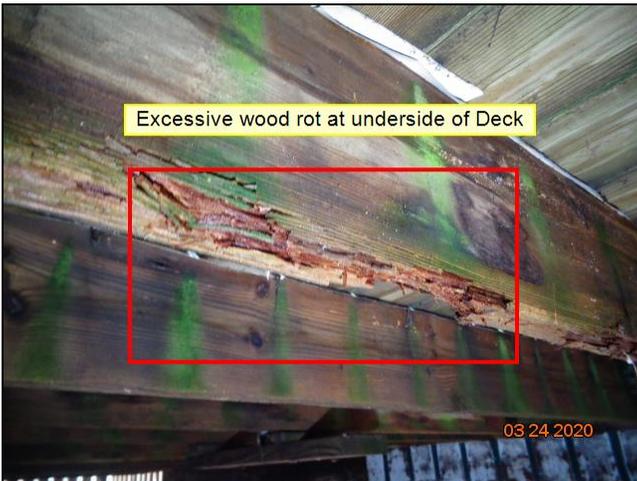
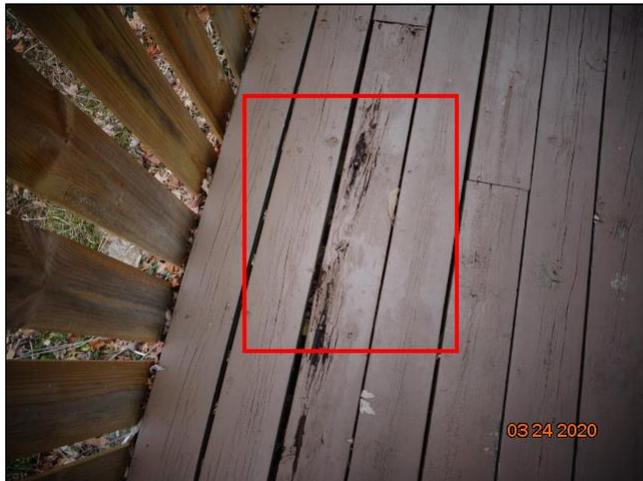
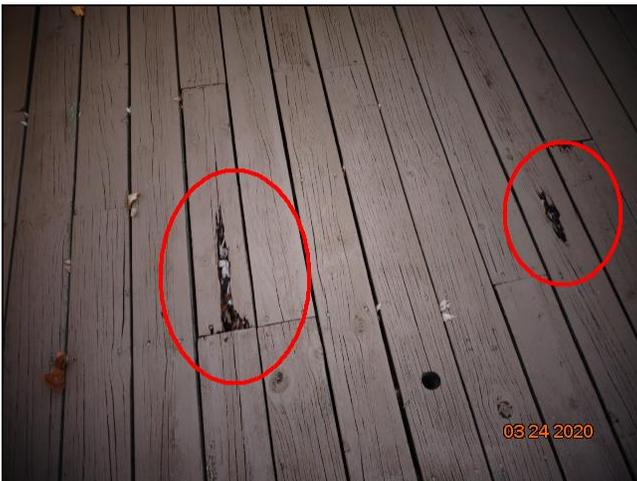
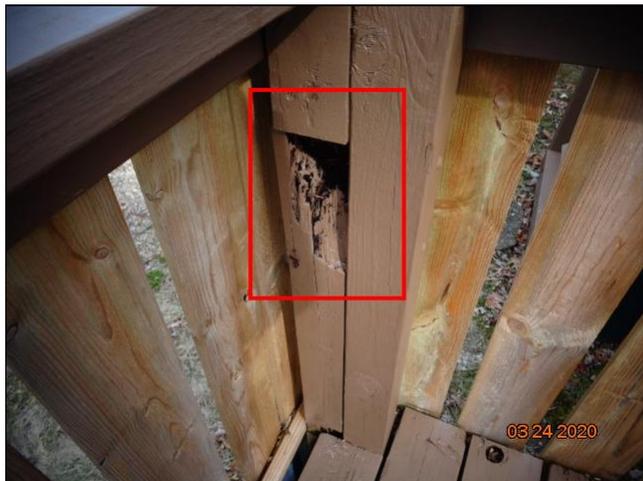
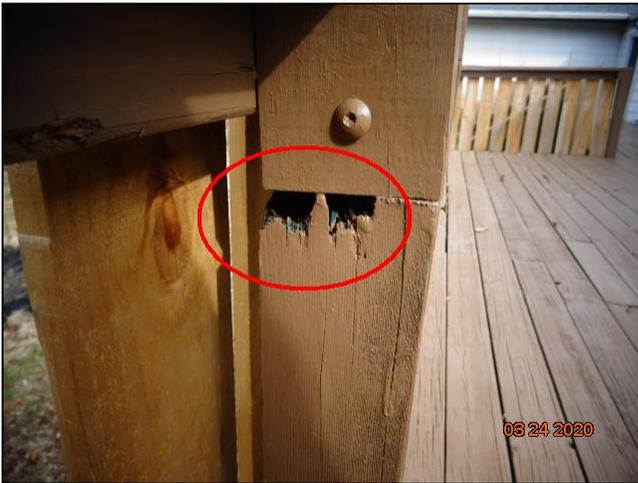
1.3 Item 5(Picture)

✘ 1.3 (5) Deck boards/framing have wood rot present, recommend proper repairs.

1.3 (8) Recommend further evaluation and proper repairs by a qualified professional Deck contractor.

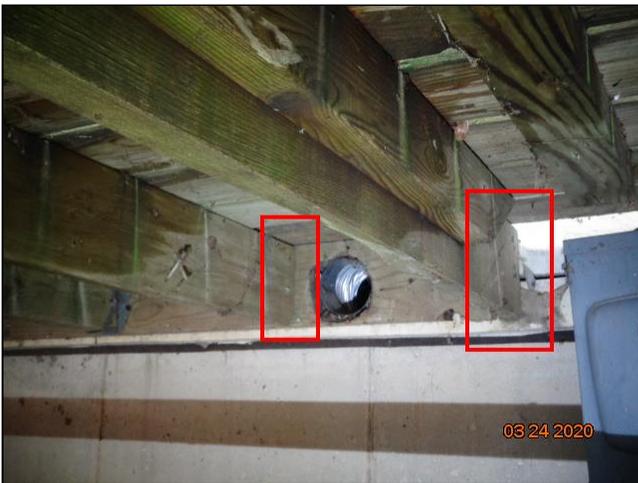
1.3 Item 10(Picture)

1.3 (6) Joist hangers are not installed at Deck, recommend proper repairs.

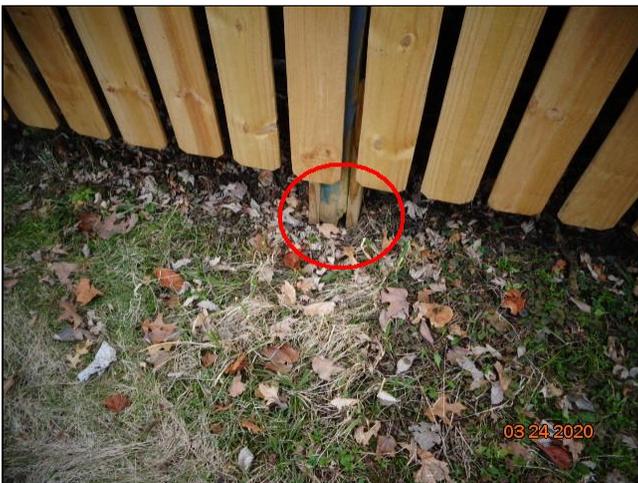
1.3 Item 11(Picture)

1.3 (7) Deck support columns in direct contact with soil/grading is not a recommended practice, repair as needed.

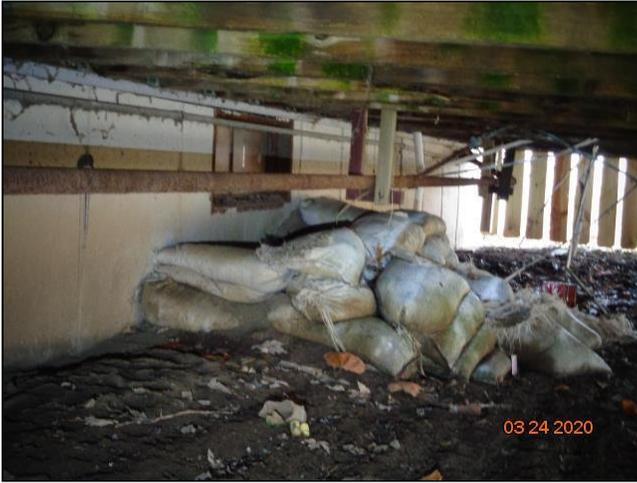
1.4 Item 1(Picture)

1.4 (1) A number of sand bags have been installed at north Basement window, recommend inquiring with current owner regarding past flooding issues within the home/yard/property. (Note: Wetland area/creek is present directly behind the home).

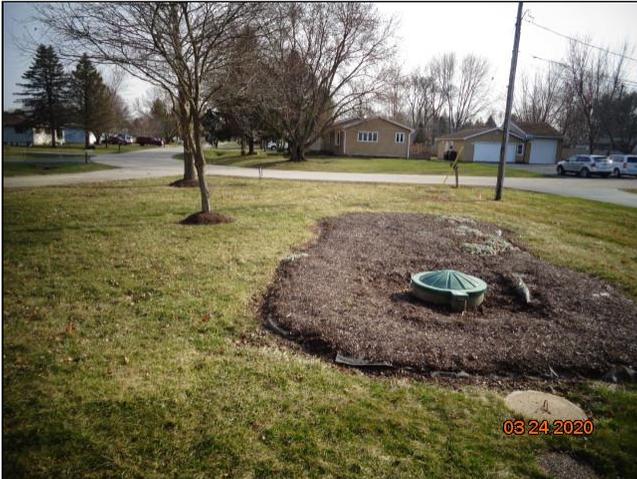
1.4 Item 2(Picture)

1.4 (2) Low areas next to the foundation are in need of additional back-fill (dirt) and/or re-grading to prevent water intrusion entering the home, recommend proper repairs.

1.4 (3) Grading/yard/driveway back-pitches towards house/foundation in areas.

1.4 (4) Maintain a positive drainage slope away from the foundation.

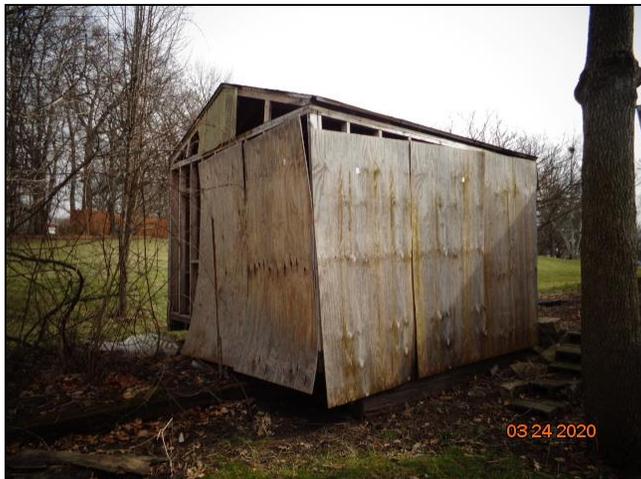
1.5 Item 1(Picture)

1.5 Rear backyard storage shed was in poor condition, recommend removal.

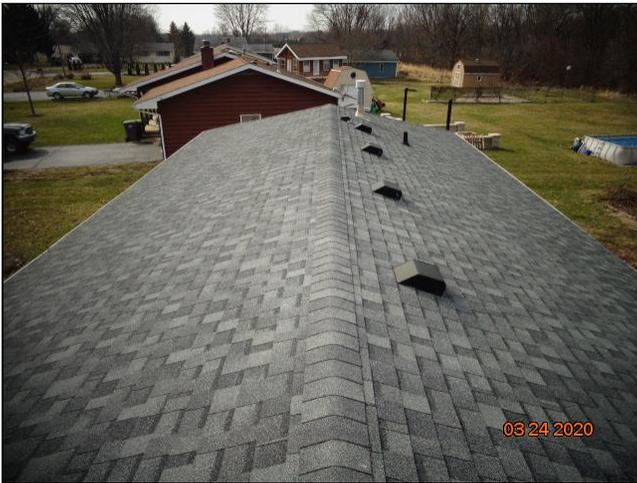
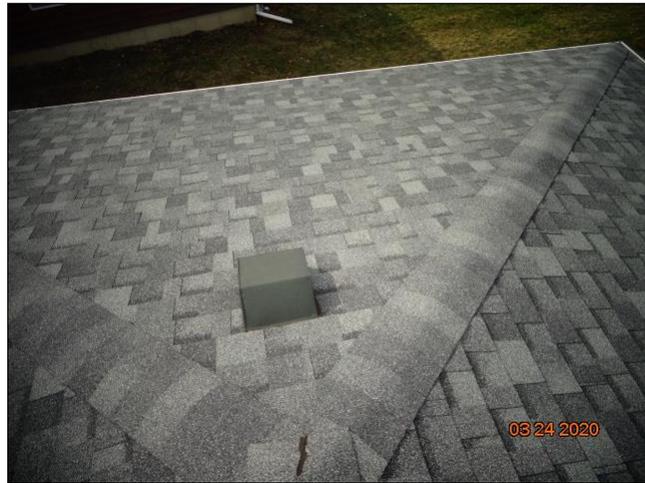
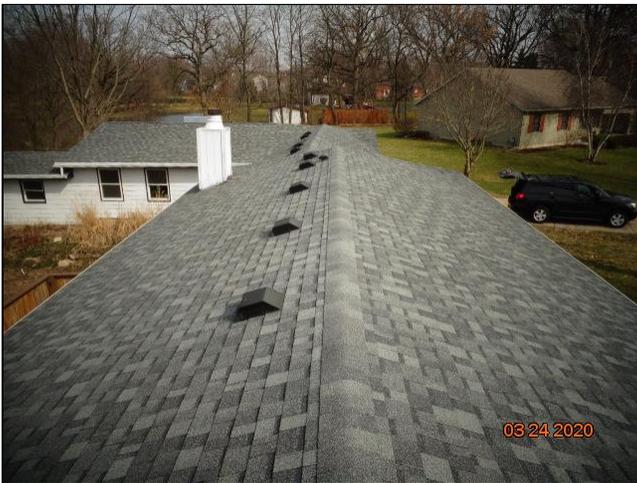
2.0 Item 1(Picture)

2.0 (1) Newer roofing shingles were present.

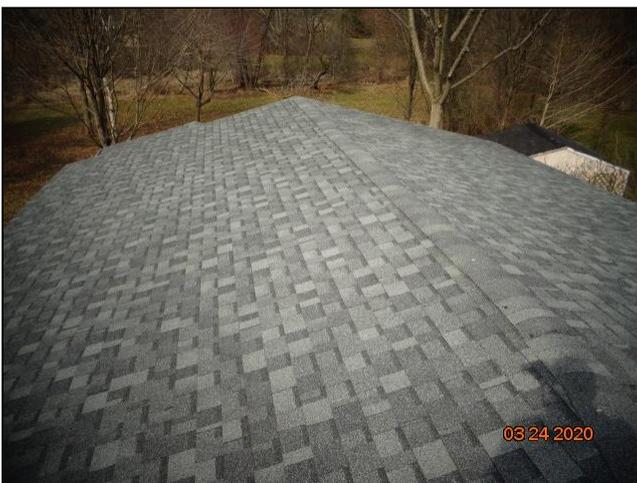
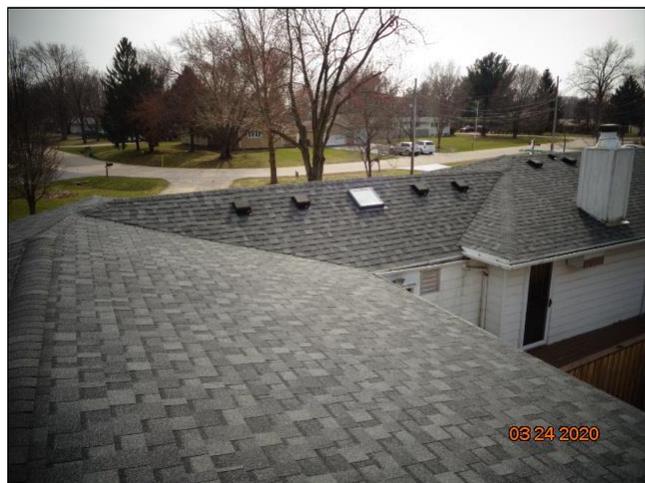
2.0 Item 4(Picture)

2.0 (2) Roofing shingles were showing normal wear and were in satisfactory condition.

2.1 Recommend monitoring of flashings/nail heads and sealing as needed to avoid future/potential water intrusion, as part of your typical home maintenance.

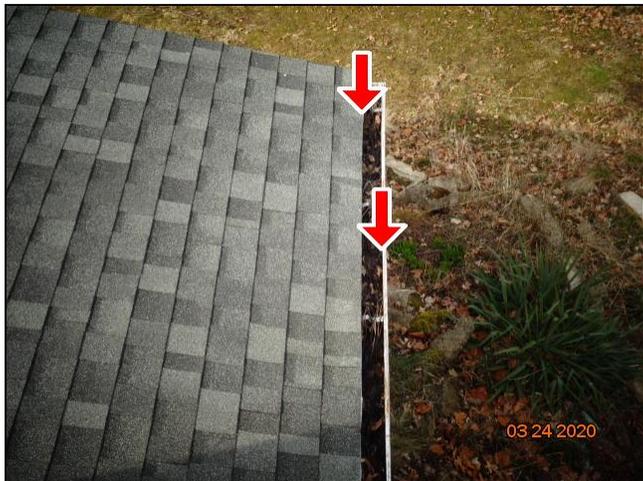
3.0 Item 1(Picture)

3.0 (2) Inside of gutters have some debris and need to be cleaned out.

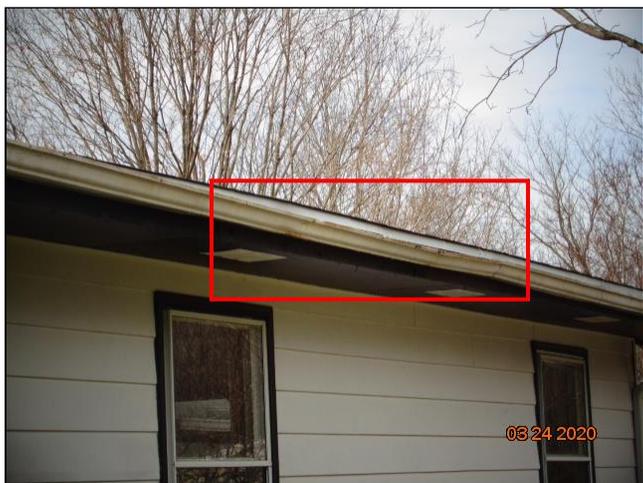
3.0 Item 2(Picture)

3.0 (3) Gutters were incorrectly pitched and in need of correction, recommend proper repairs.

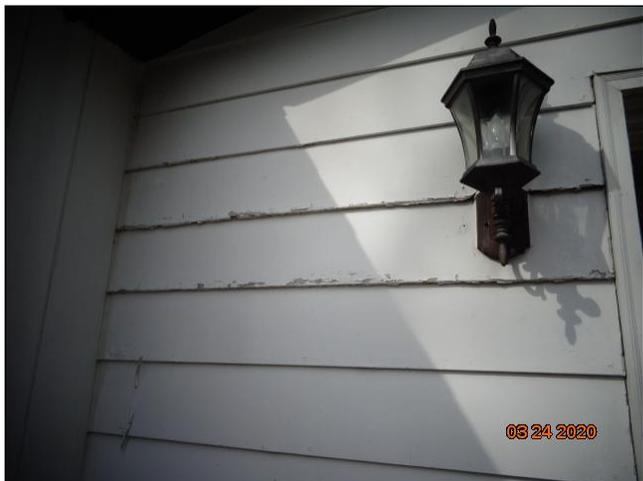
3.1 Item 1(Picture)

3.1 (1) Siding was in need of painting/staining maintenance, recommend proper repairs.

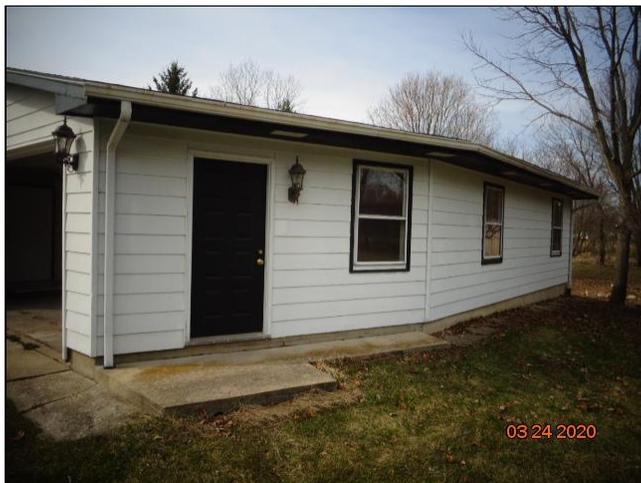
3.1 Item 3(Picture)

3.1 (2) Garage has Masonite (Headboard/Fiberboard) siding present. Masonite siding has a history of swelling and rotting over time when exposed to the elements and will prematurely deteriorate, recommend further evaluation of siding by a qualified, experienced siding contractor. For further information on this type of siding type Masonite Siding into an internet search engine.

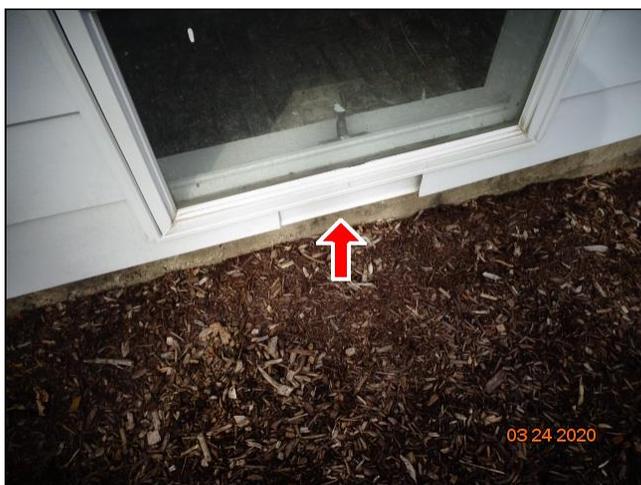
3.1 Item 4(Picture)

3.1 (3) Front siding is not installed under awning window, recommend proper repairs.

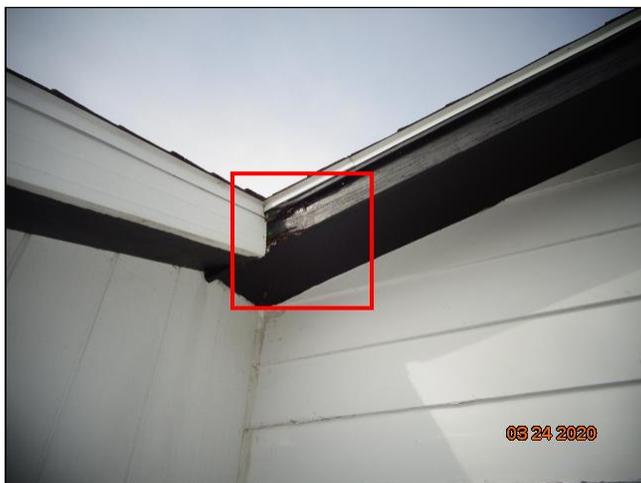
3.3 Item 1(Picture)

3.3 Fascia had some deterioration/wood rot present, recommend proper repairs.

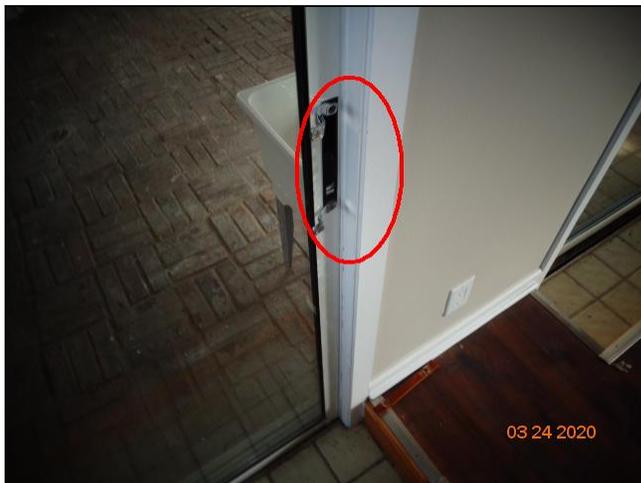
3.4 Item 2(Picture)

3.4 (3) Rear sliding door does not lock/latch properly, handle not installed, recommend proper repairs.

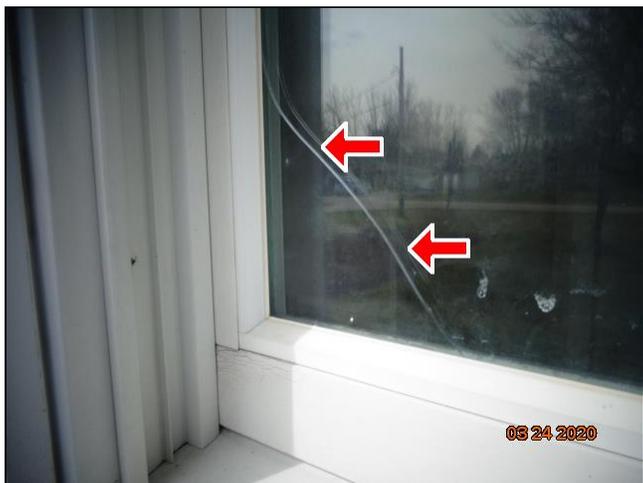
3.6 Item 1(Picture)

3.6 (3) Some windows have cracked glass present, recommend proper repairs.

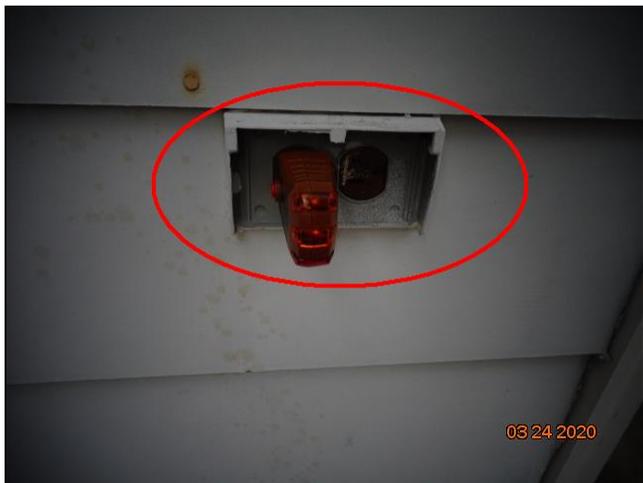
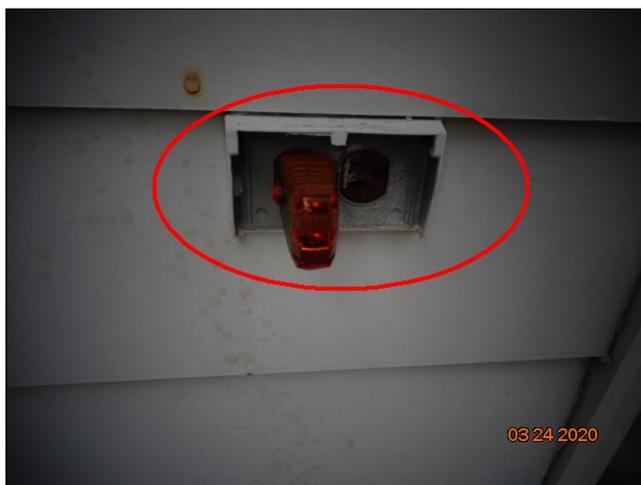
3.8 Item 1(Picture)

3.8 (1) Recommend all exterior outlet(s) are GFCI protected, potential safety hazard(s), recommend proper repairs by a qualified/licensed professional electrician.

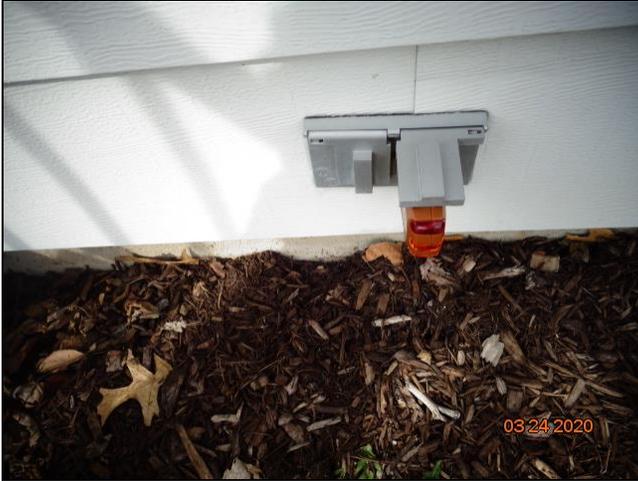
3.8 Item 2(Picture)

**3.8** (2) Exterior outlet(s) present with open grounds; potential safety hazard, recommend proper repairs by a qualified/ licensed professional electrician.

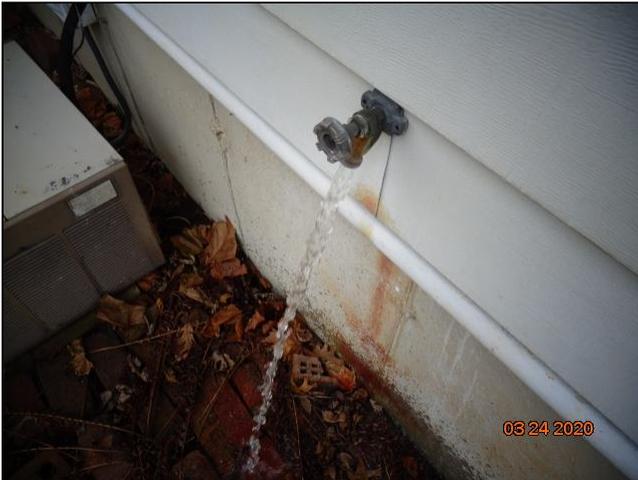
3.9 Item 1(Picture)

3.9 (1) Exterior hose faucet(s) were operational at time of inspection.

3.9 (2) Recommend a frost free/anti-siphon exterior hose faucet(s) are installed, recommend proper repairs.

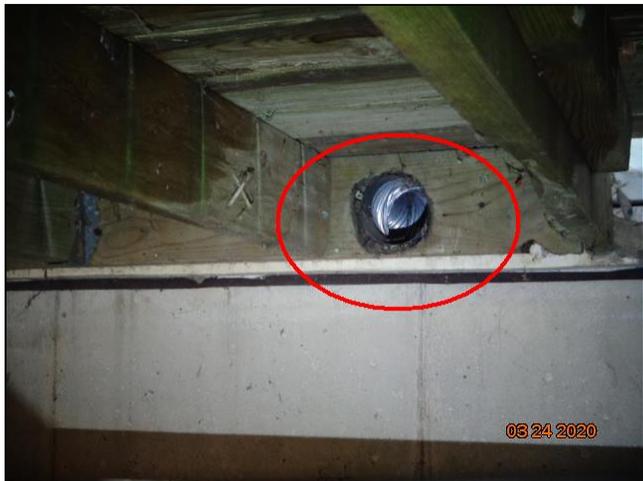
3.10 Item 1(Picture)

3.10 Rear exterior vent is missing covers/louvers, recommend proper repairs.

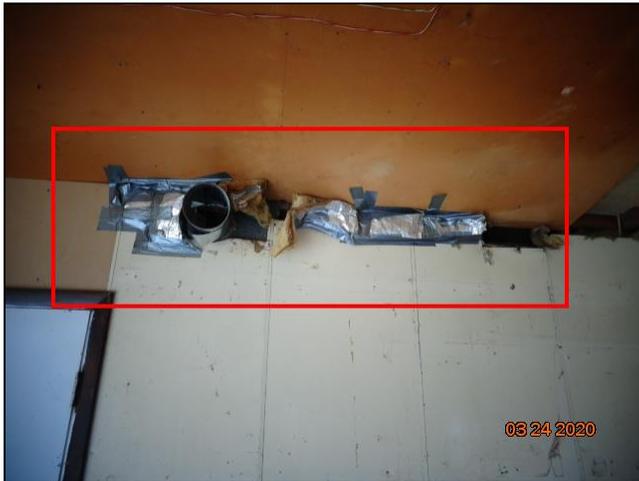
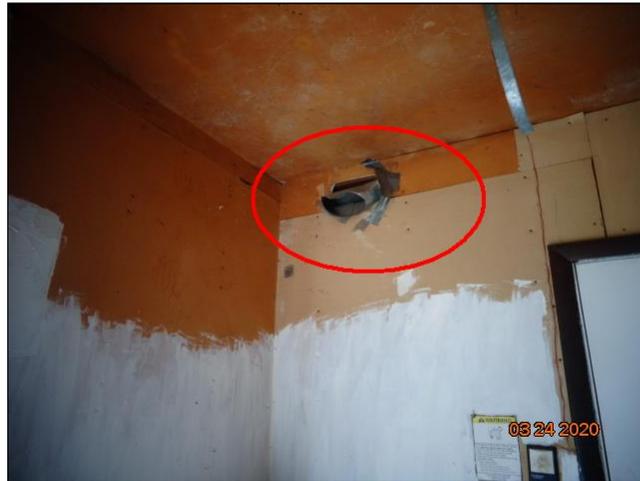
4.1 Item 1(Picture)

✘ 4.1 Firewall (fire-rated drywall, 5/8"/Type X) between Garage and House wall is not present; potential safety hazard, recommend proper repairs.

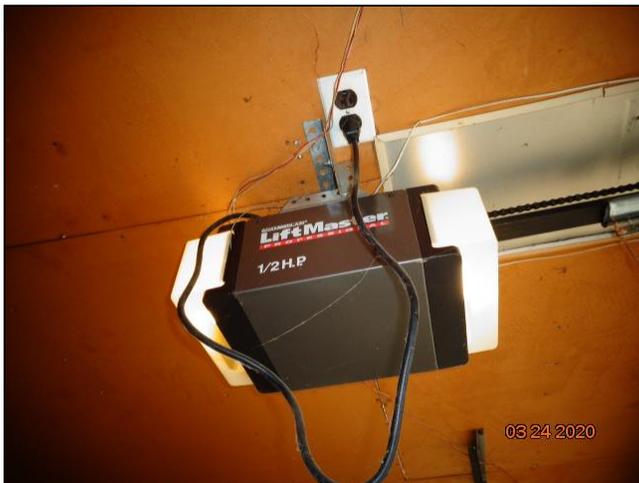
4.5 Item 1(Picture)

4.5 (1) Older garage door opener is present, Client should budget for replacement in the near future.

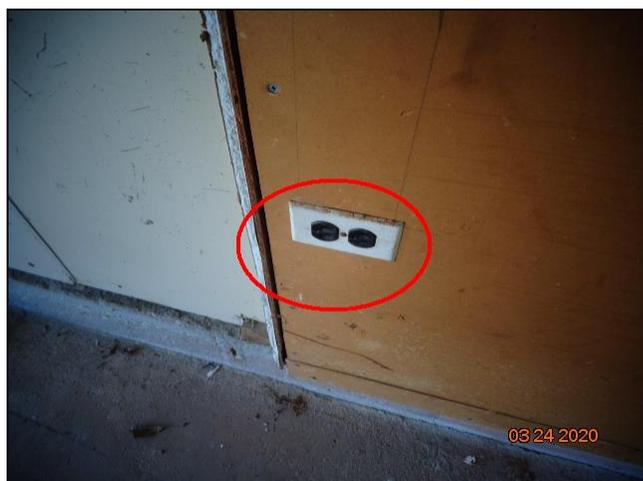
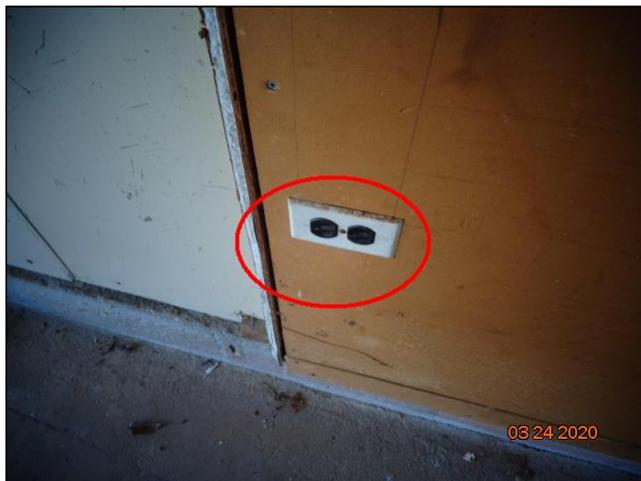
4.6 Item 1(Picture)

4.6 (1) Recommend all Garage outlets are GFCI protected, recommend proper repairs by a qualified/licensed professional electrician.

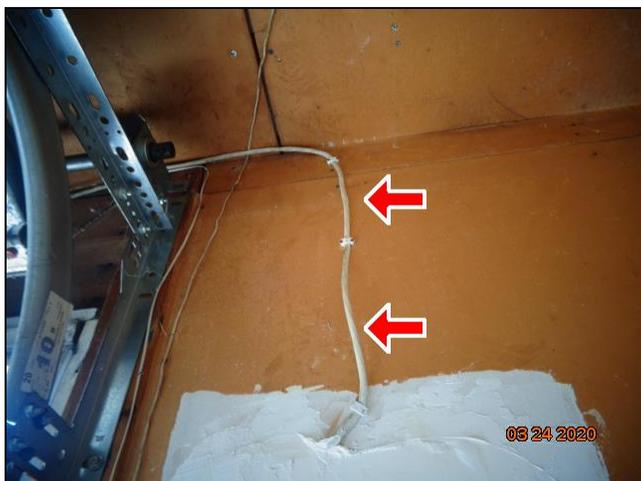
4.6 Item 4(Picture)

4.6 (2) Exposed romex present in Garage is no longer a recommended practice, recommend proper repairs by a qualified/ licensed professional electrician.

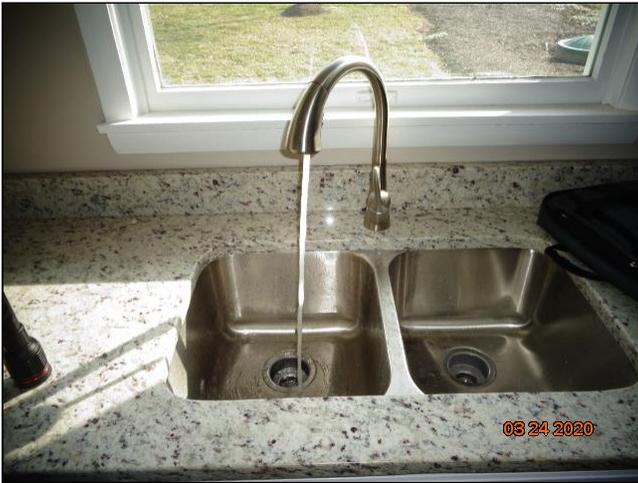
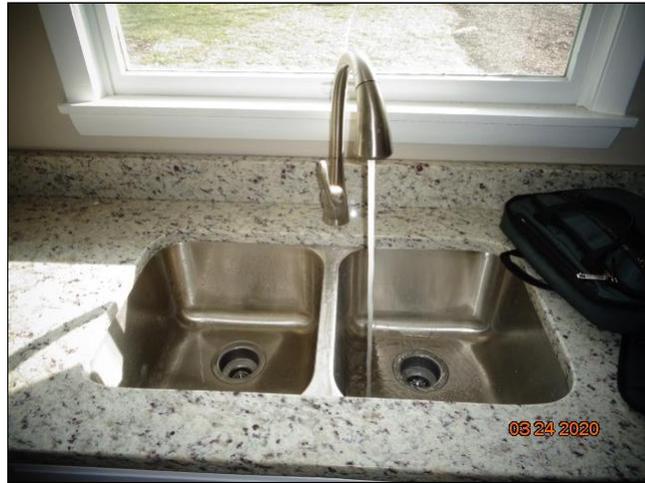
5.2 Item 1(Picture)

5.2 Plumbing supply lines showed no signs of leakage at time of inspection.

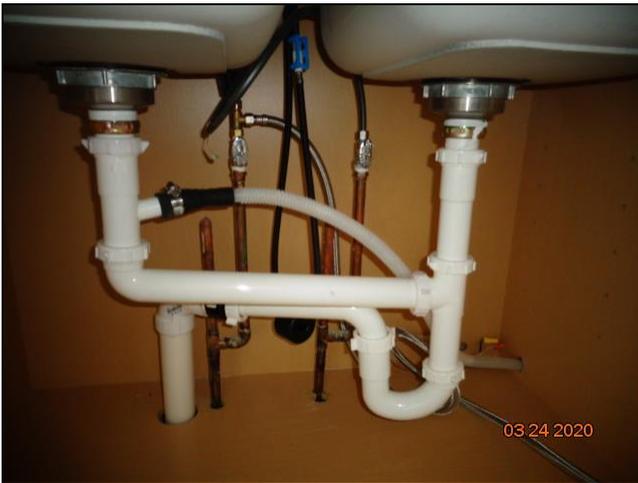
5.3 Item 1(Picture)

5.3 (1) Plumbing drain lines showed no signs of leakage at time of inspection.

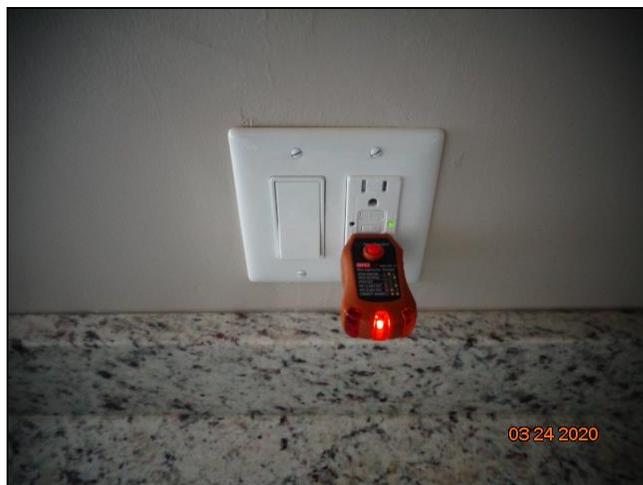
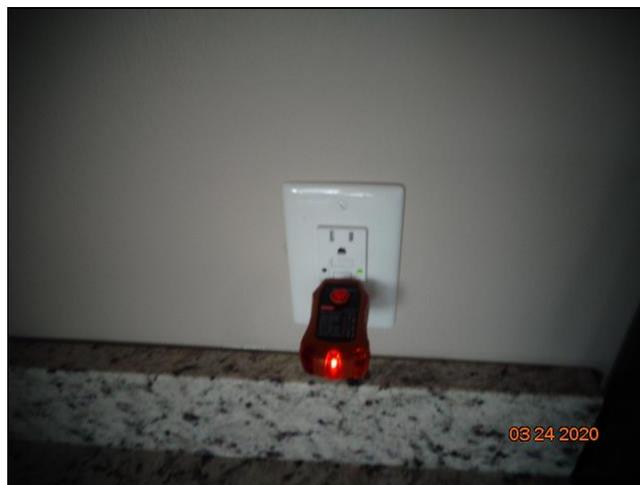
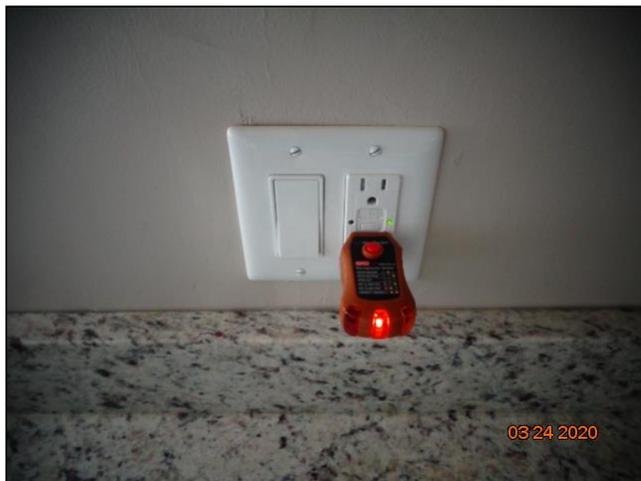
5.10 Item 1(Picture)

✘ 5.10 Kitchen outlet(s) have open ground(s) present; potential safety hazard, recommend proper repairs by a qualified/ licensed professional electrician.

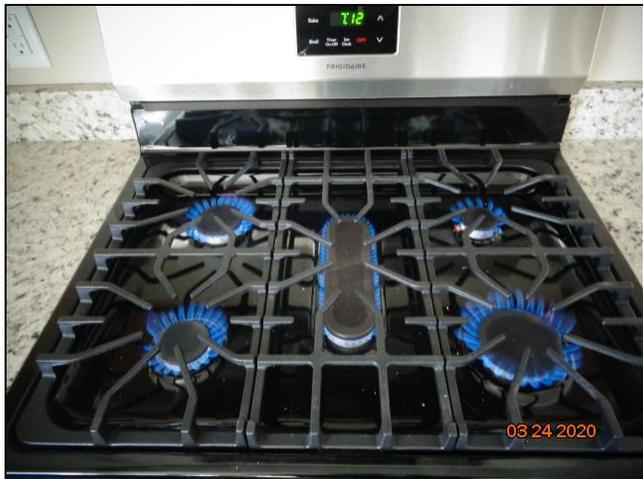
5.13 Item 1(Picture)

5.13 Stove/cooktop was operable at time of inspection.

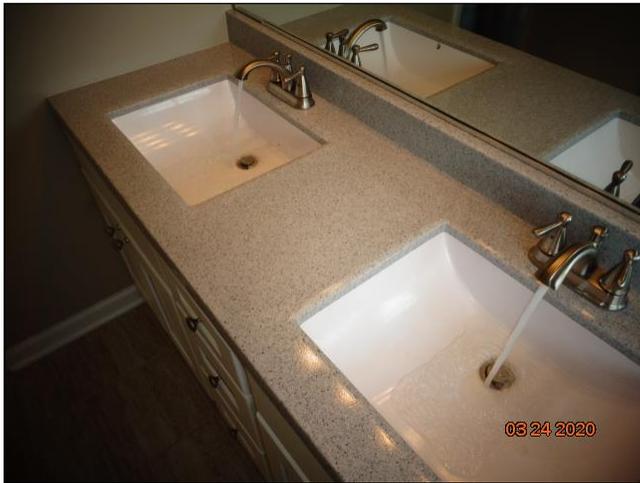
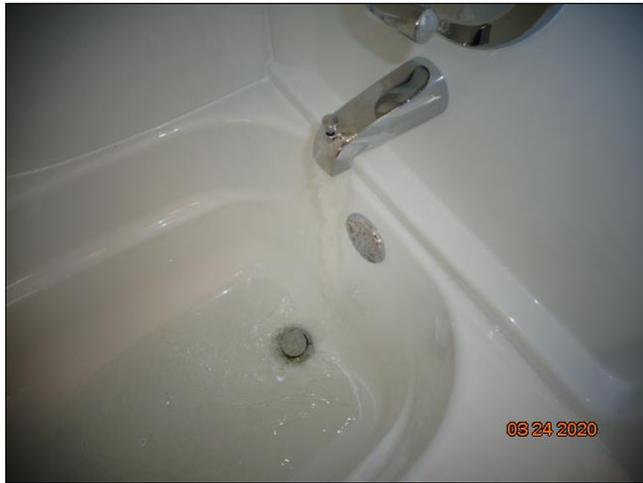
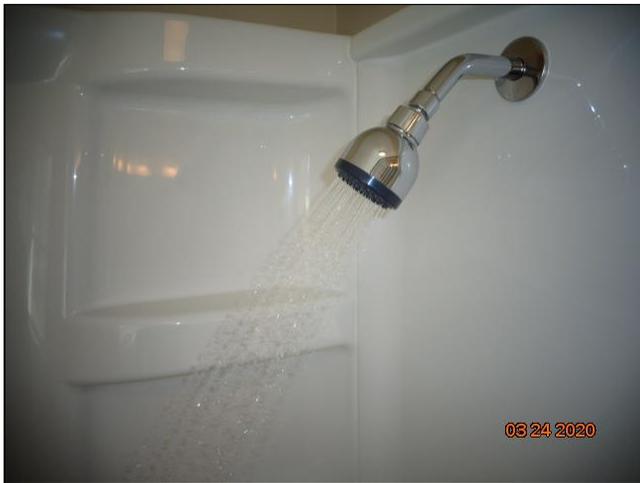
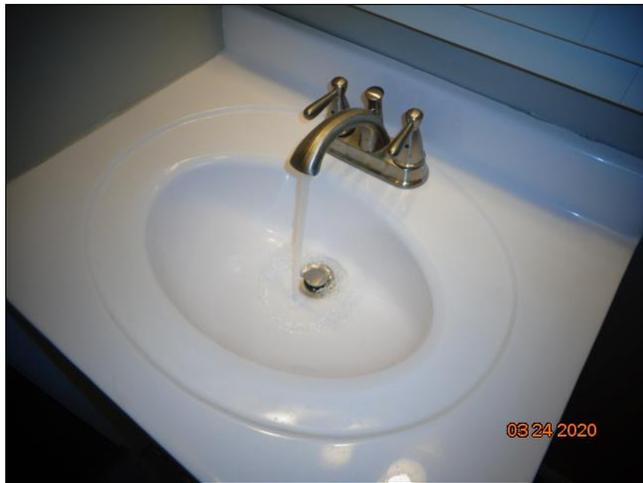
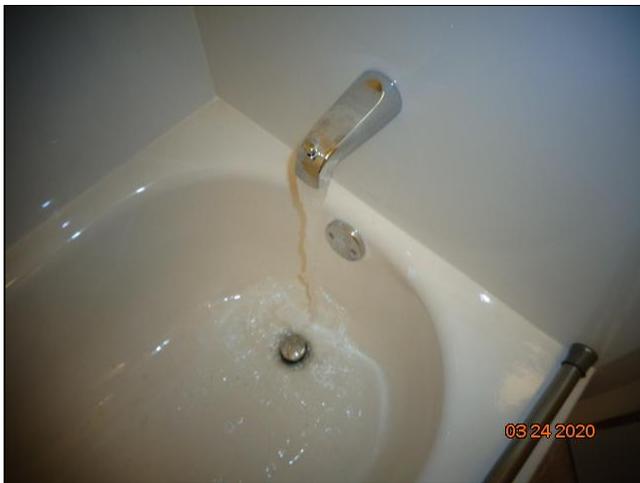
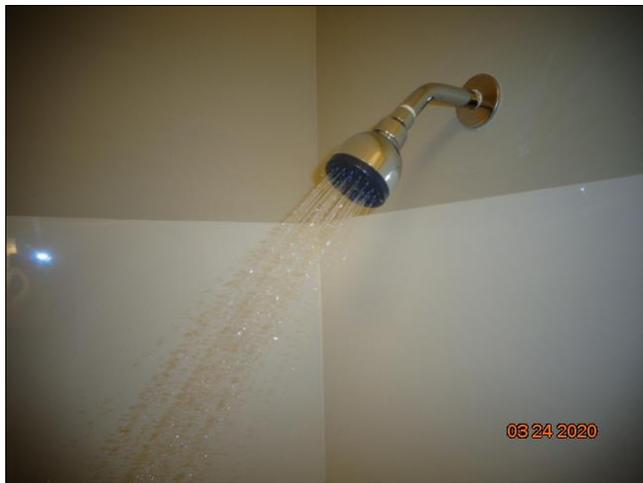
7.6 Item 1(Picture)

7.6 (1) Plumbing supply lines showed no signs of leakage at time of inspection.

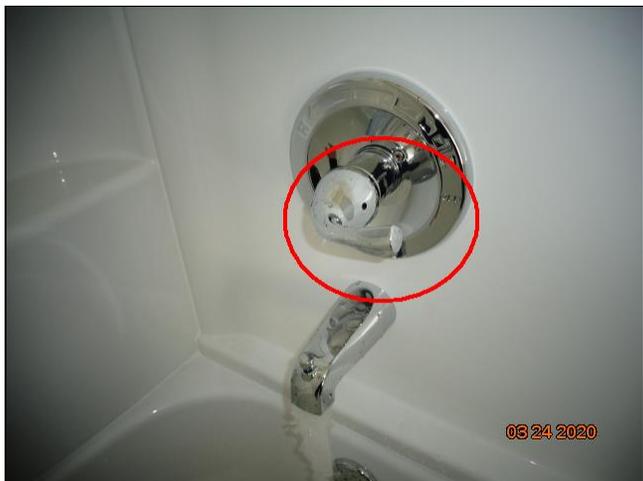
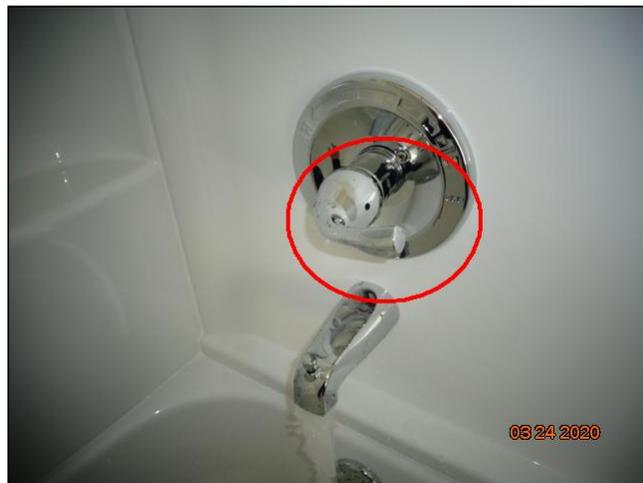
7.6 Item 7(Picture)

7.6 (2) Hot water was not present at tub faucets, handles did not rotate completely to hot side, recommend further evaluation and proper repairs by a qualified/licensed professional plumber.

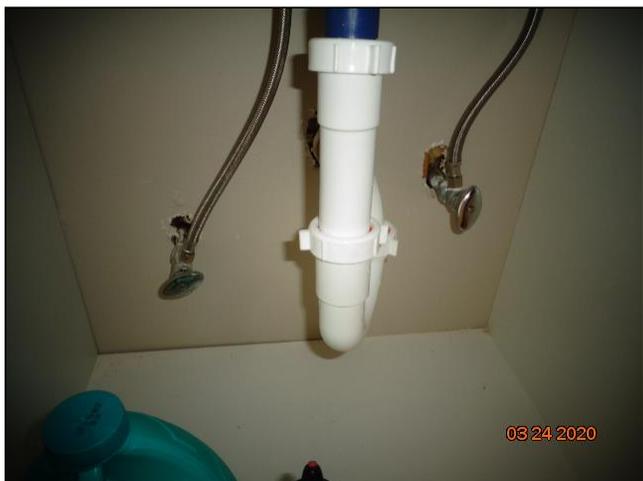
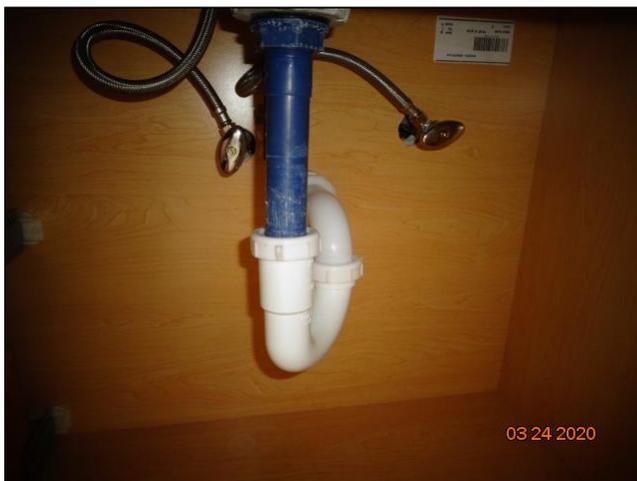
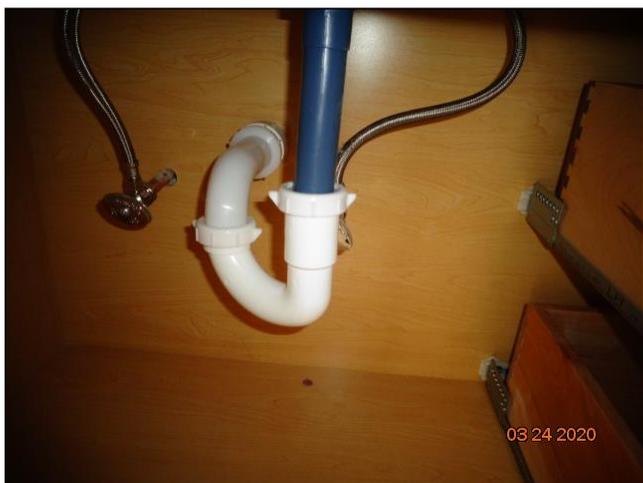
7.7 (1) Plumbing drain lines showed no signs of leakage at time of inspection.

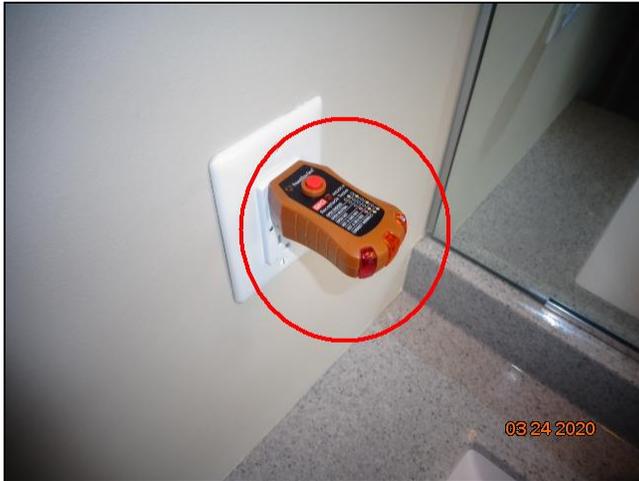
7.8 Item 1(Picture)

7.8 Bathroom outlet(s) present with an open ground(s); potential safety hazard, recommend proper repairs by a qualified/licensed professional electrician.

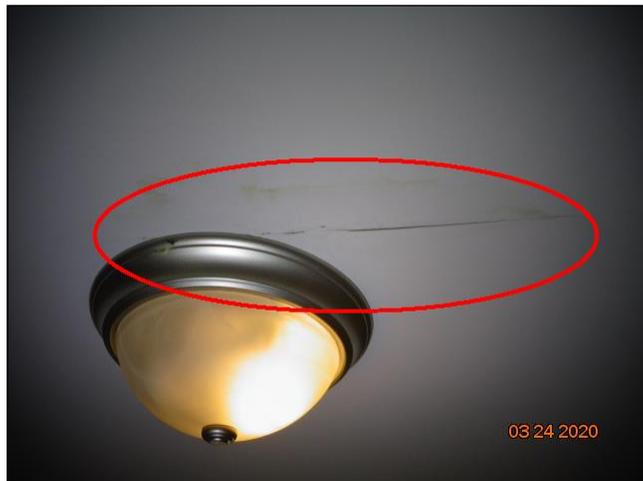
8.1 Item 1(Picture)

8.1 (1) Staining/water marks were present on ceiling area of North Bedroom, recommend further evaluation and proper repairs.

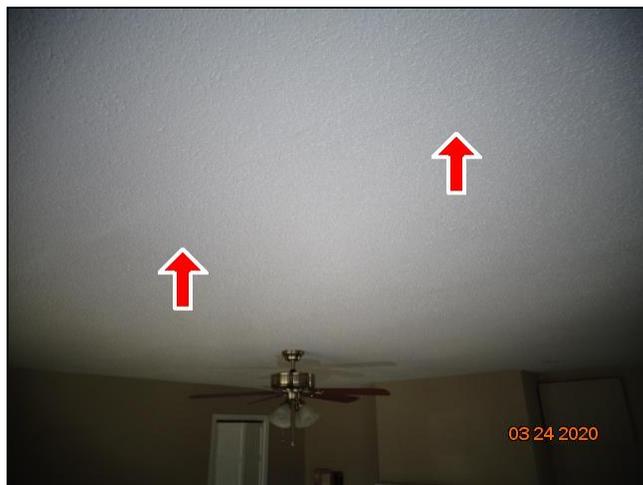
8.1 Item 2(Picture)

8.1 (2) Textured/"Popcorn" ceilings were present in the home, which may possibly contain an asbestos like material, recommend further evaluation/testing by a qualified contractor as needed.

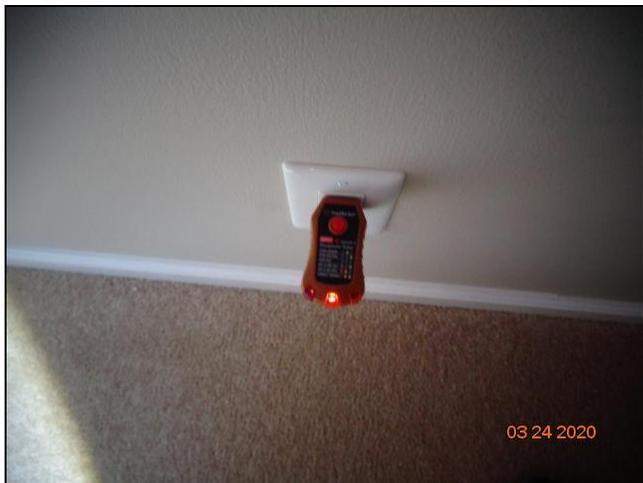
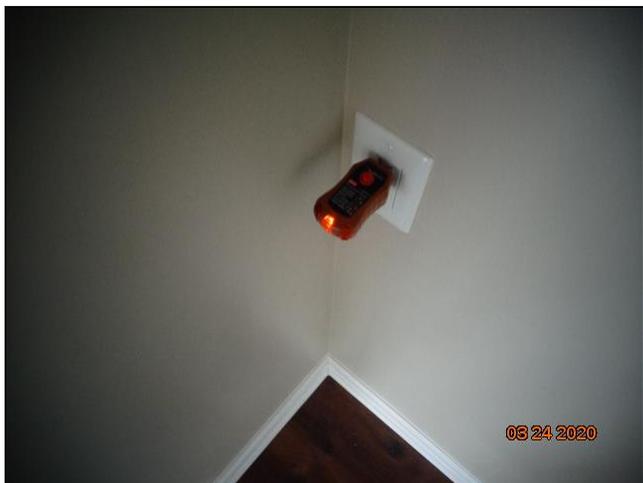
8.5 Item 1(Picture)

8.5 The majority of the three prong outlets are not properly grounded, recommend proper repairs by a qualified/licensed professional electrician.

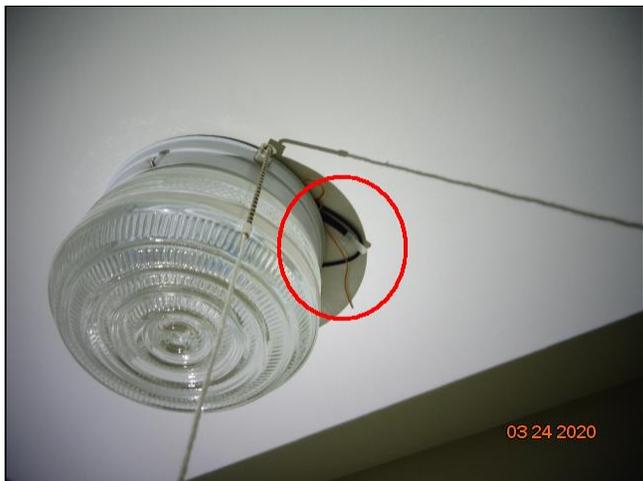
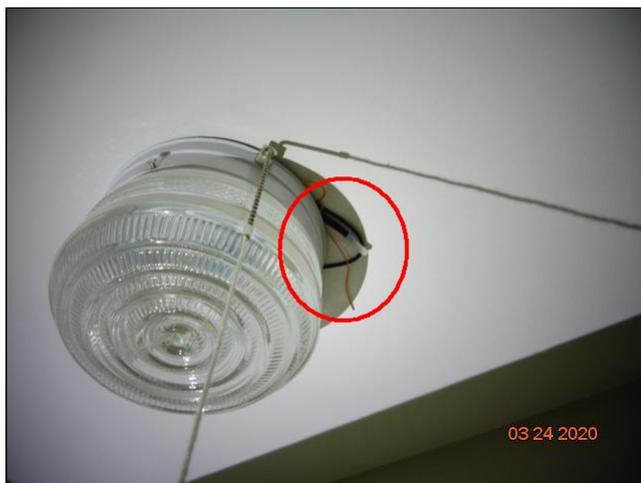
8.6 Item 1(Picture)

8.6 (2) Exposed wiring is present at Bedroom closet light fixture, recommend proper repairs.

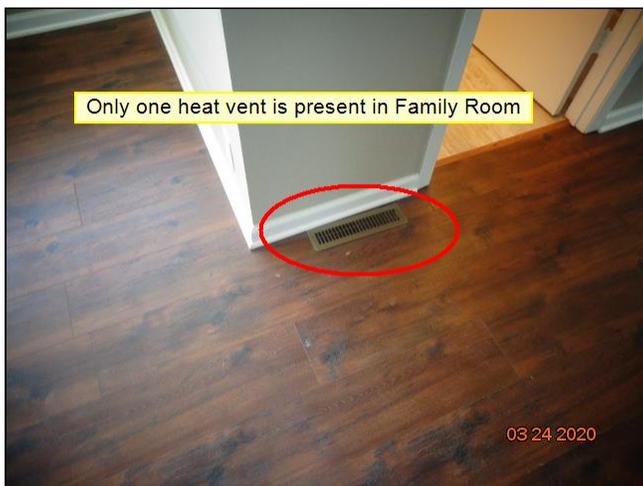
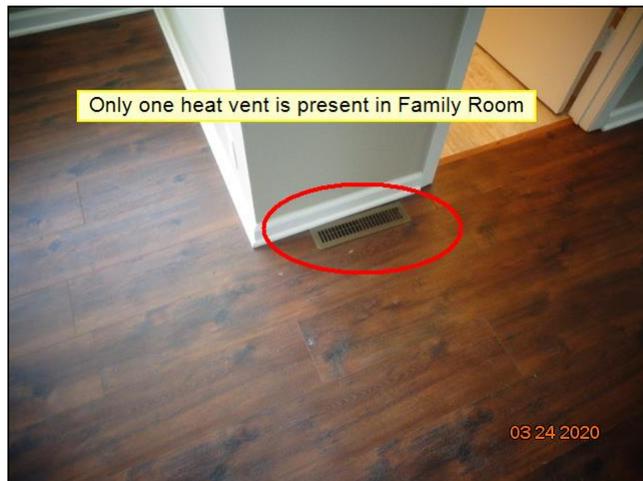
8.7 Item 1(Picture)

8.7 Recommend additional heat vents are installed in East Family area, large temperature differential was present between Family Room and the rest of the house.

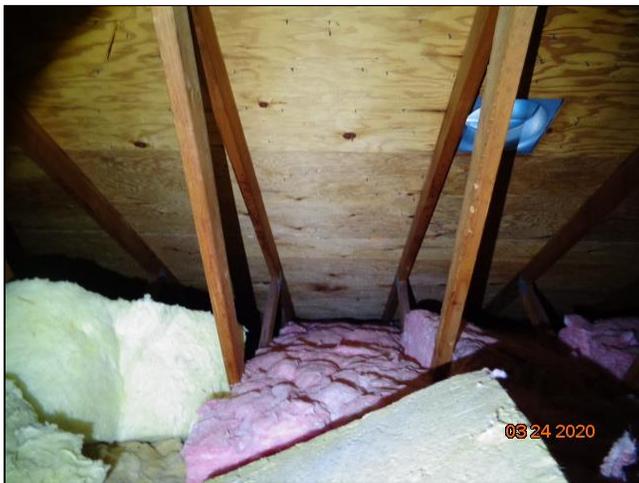
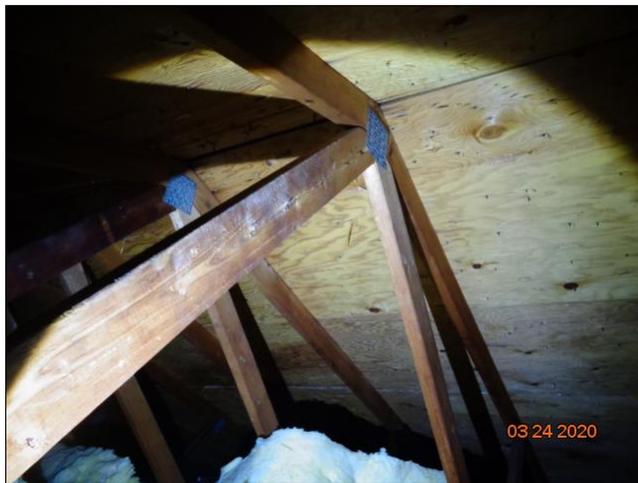
10.0 Roof sheathing showed no major defects.

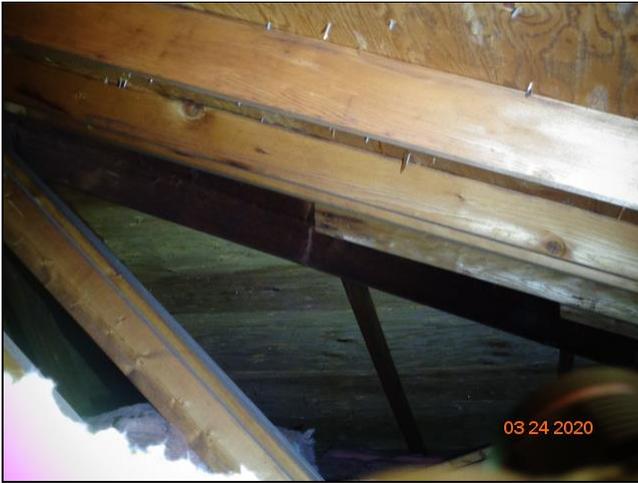
10.1 Item 2(Picture)

10.1 (2) Rafters showed no major defects and were in satisfactory condition.

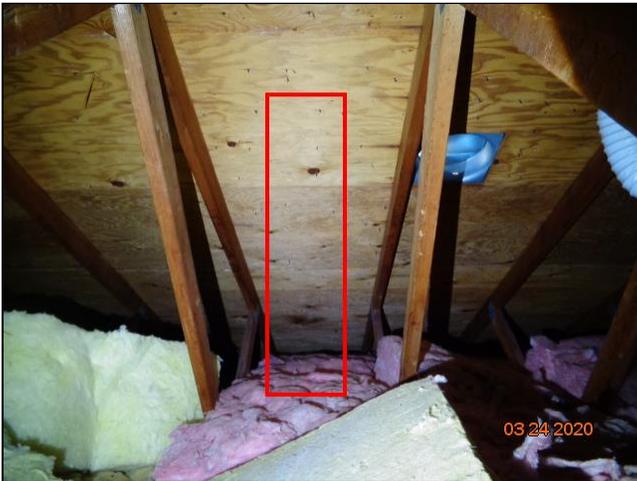
10.3 Item 1(Picture)

❌ 10.3 (1) Recommend additional ventilation is installed in attic area, recommend proper repairs by a qualified/licensed professional contractor/roofer.

❌ 10.3 (2) Recommend air baffles/channel vents are installed at soffit vents for additional ventilation, recommend proper repairs.
