Inspection Report

Property Address:
1234 Main Street
Anytown IL 60554

Quality Assurance Home Inspections, Inc.

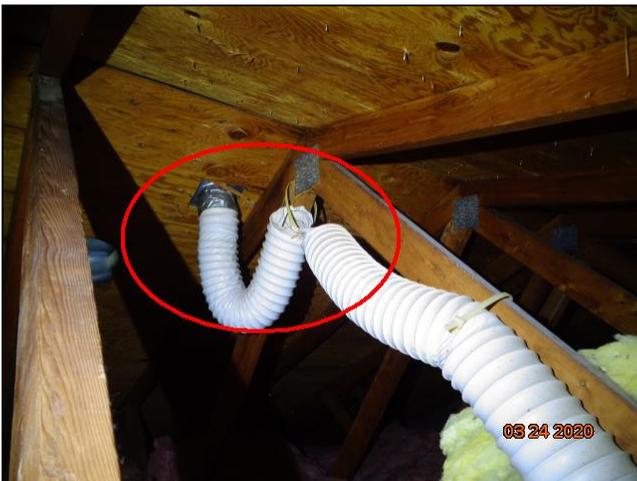
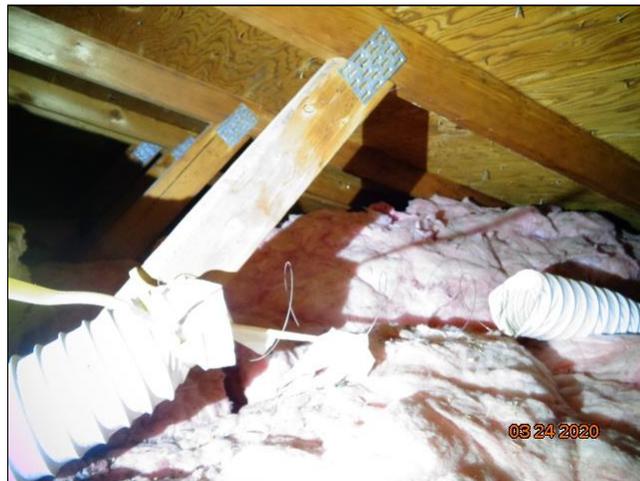
❌ 10.4 Recommended extending exhaust fans venting to the exterior to dedicated discharge(s), recommend proper repairs.

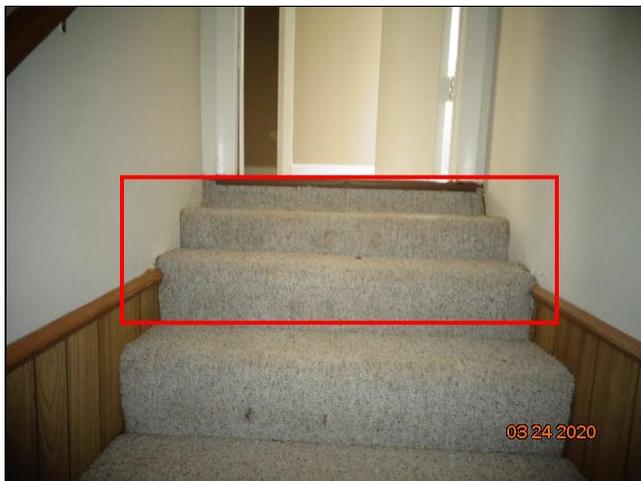
11.0 Item 1(Picture)

✘ 11.0 Basement staircase has uneven riser heights present, potential safety/trip hazards present, recommend proper repairs.

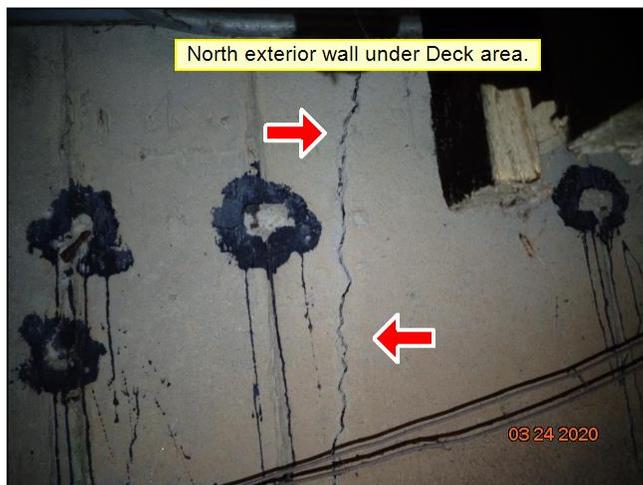
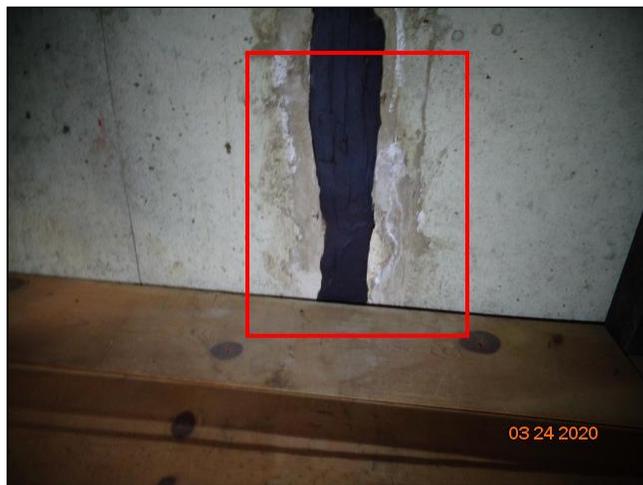
11.1 Item 1(Picture)

✘ 11.1 (1) Foundation wall shows evidence of cracking/movement and are in need of additional patching/repairs, recommend further evaluation and proper repairs by a qualified professional foundation contractor.

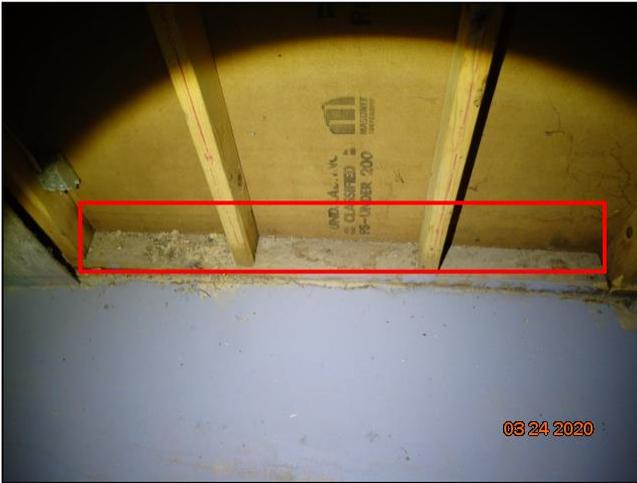
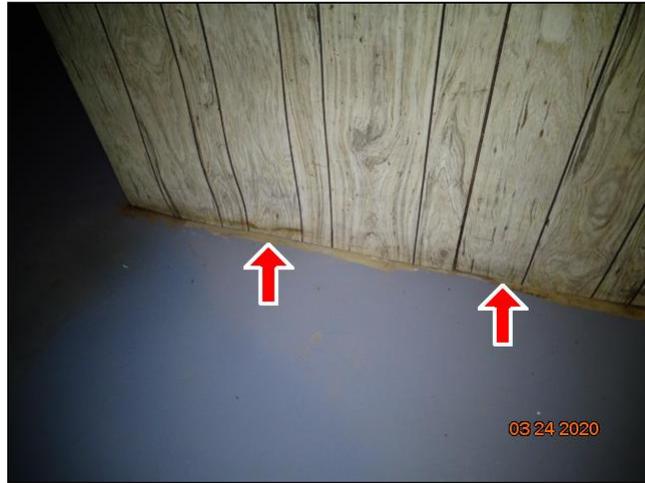
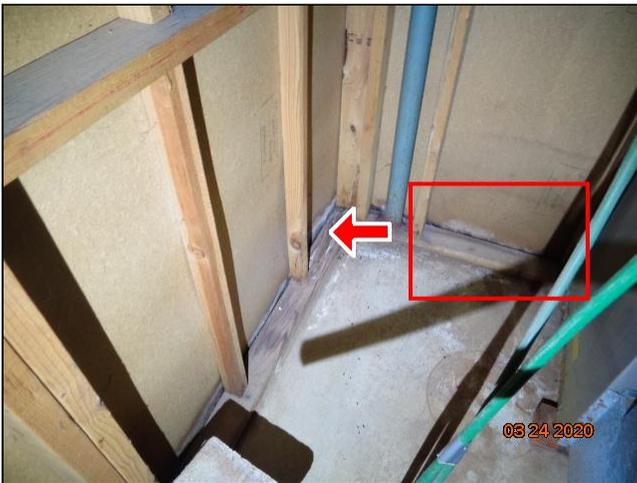
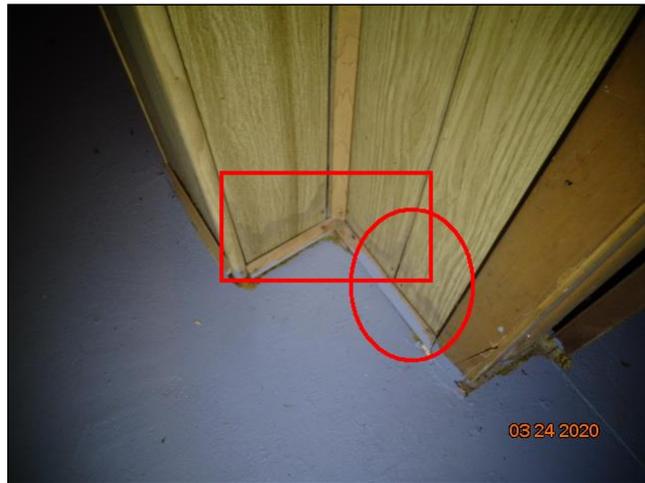
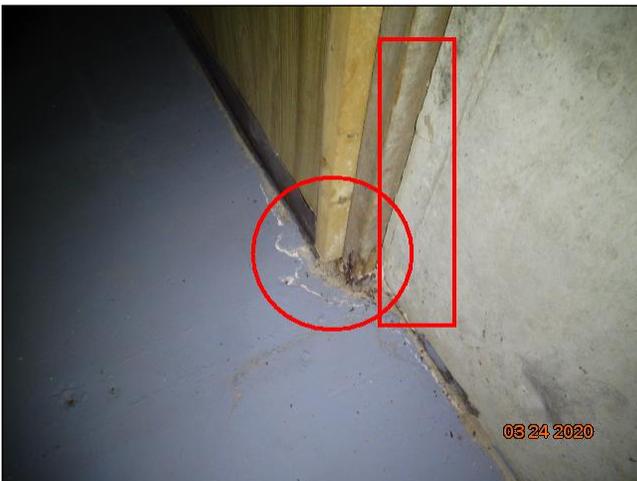
✘ 11.1 (2) Evidence of water intrusion is apparent in Basement area (water lines present in a number of areas throughout the Basement), recommend inquiring with current owner (and obtaining property disclosures) regarding past water issues/intrusion in Basement area, recommend further evaluation and proper repairs.

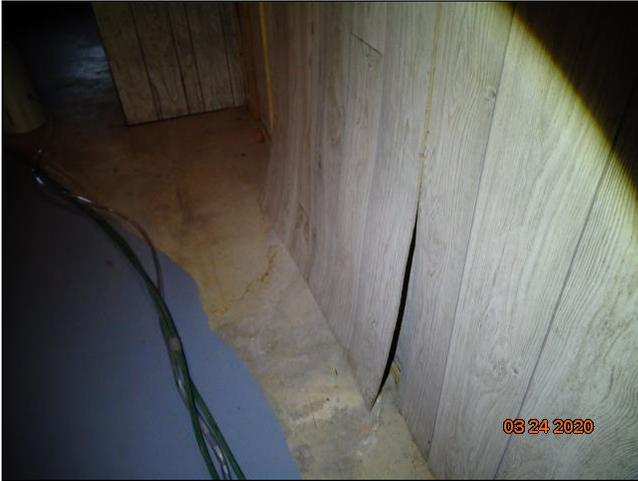
11.1 Item 9(Picture)

11.1 (4) Paneling was warped in a number of areas, from water intrusion, recommend proper repairs.

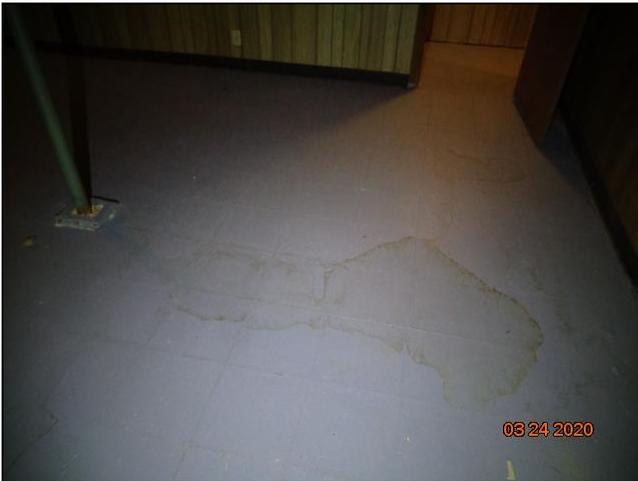
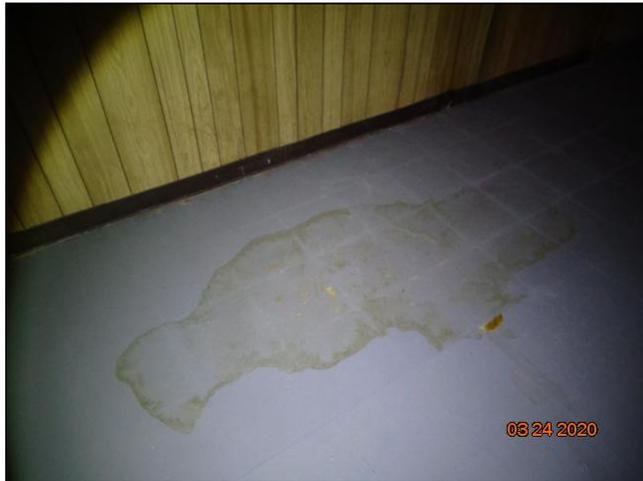
11.2 (1) **Evidence of water intrusion is apparent in Basement area, recommend inquiring with current owner (and obtaining property disclosures) regarding past water issues/intrusion in Basement area, recommend further evaluation and proper repairs.**

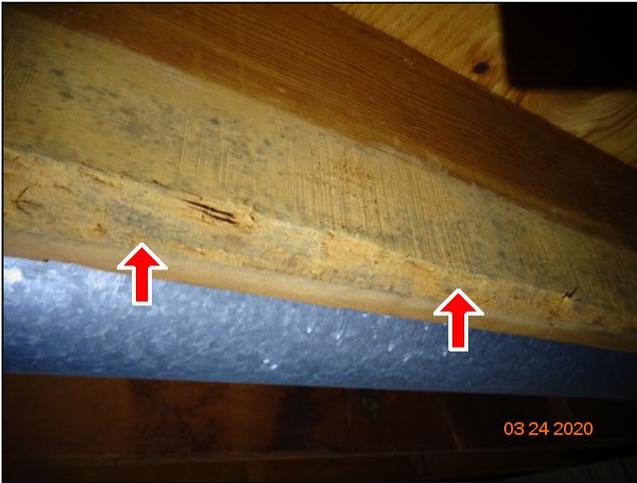
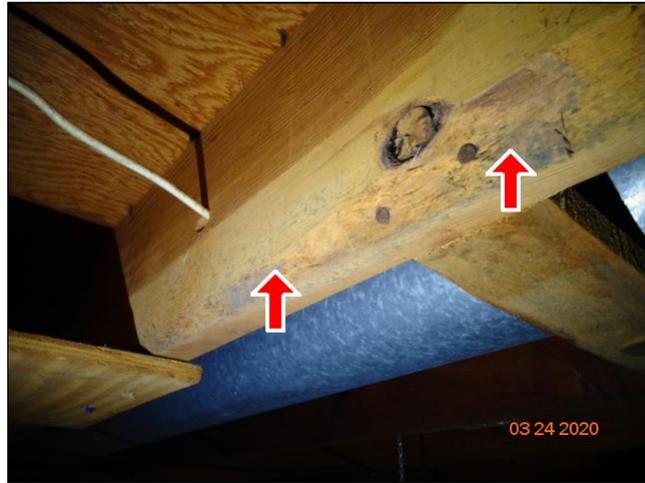
☒ 11.5 (1) Evidence of microbial growth; a mold/mildew/fungi like substance was visible at time of inspection in Basement area on floor joists; potential safety hazards, recommend further evaluation (air testing/tape lifts) and proper repairs (remediation) by qualified/certified/experienced/reputable professional mold contractors.

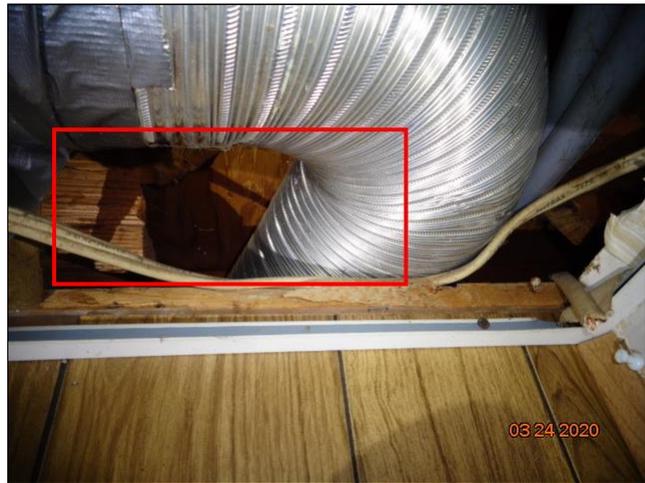
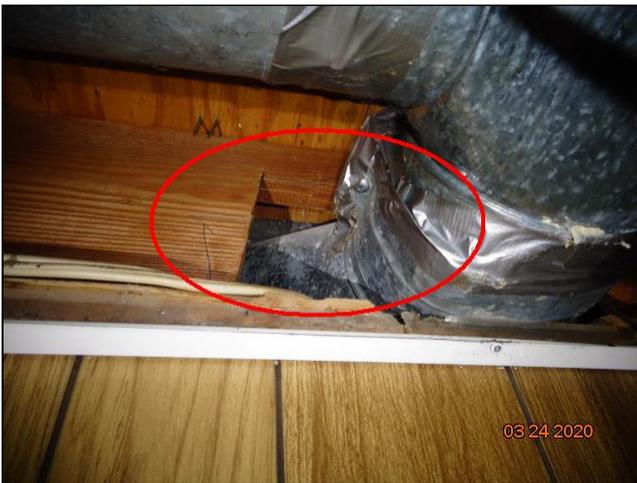
☒ 11.5 (2) Floor joist(s) has been improperly cut/notched, recommend proper repairs/re-supporting.

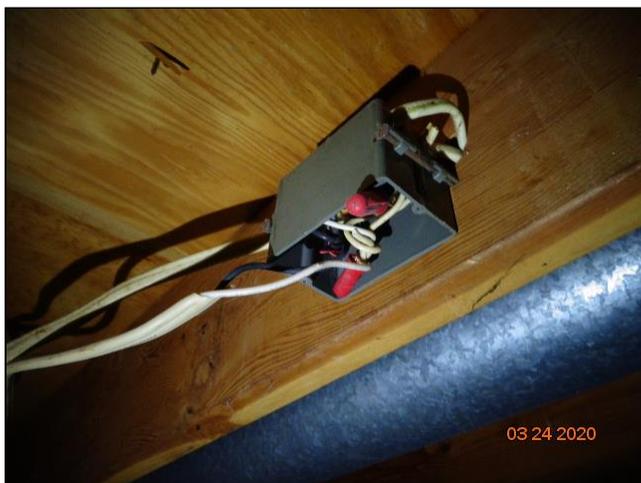
11.7 Item 1(Picture)

11.7 (2) Open junction box present in need of a cover plate, recommend proper repairs.

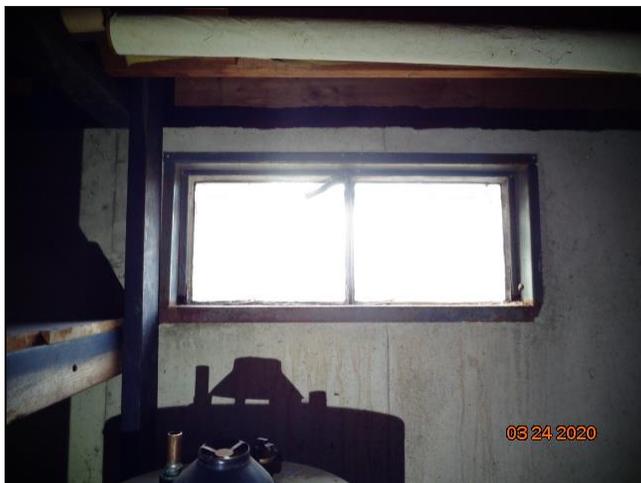
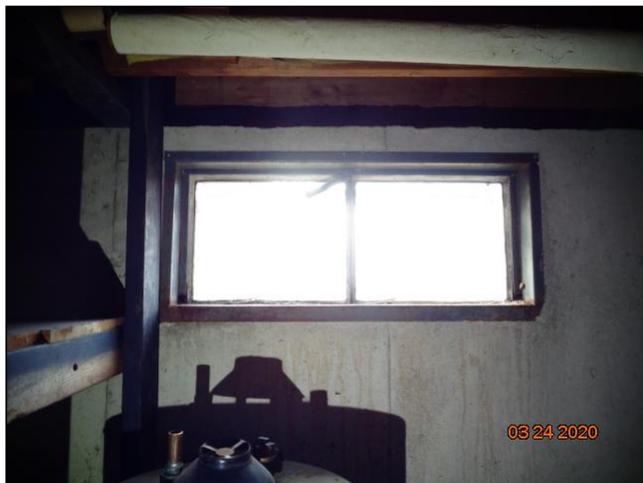
11.8 Item 1(Picture)

11.8 Fire-escape windows are not present for secondary emergency egress, do not use Basement area for sleeping purposes; potential safety hazard, recommend proper repairs as needed.

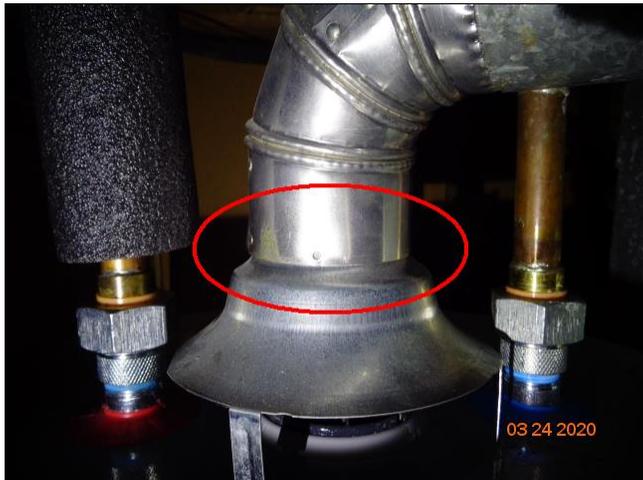
12.1 Item 1(Picture)

12.1 Recommend water heater flue is secured to draft hood, recommend proper repairs.

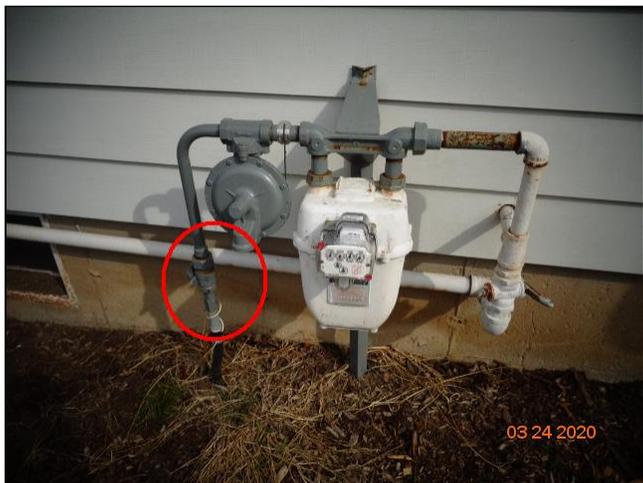
12.4 Item 1(Picture)

12.4 FYI...main gas shut off valve(s) at exterior meter.

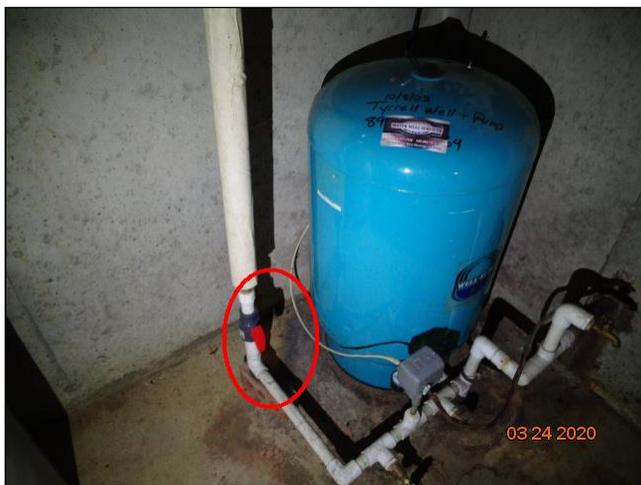
12.5 Item 1(Picture)

12.5 FYI...main water shut off valve(s).

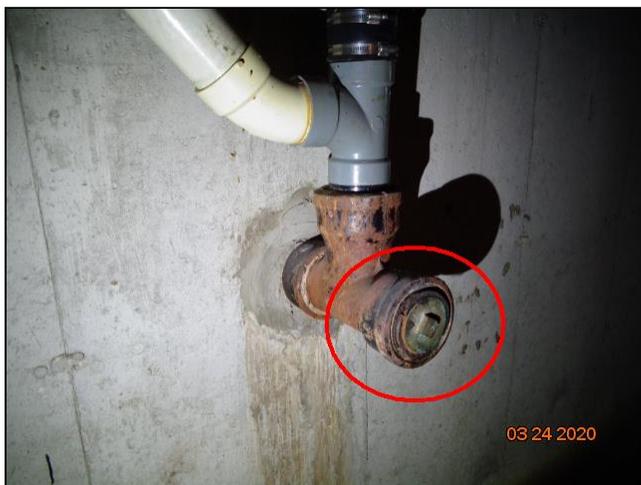
12.6 Item 1(Picture)

12.6 FYI...main sewer clean-out cap/access.

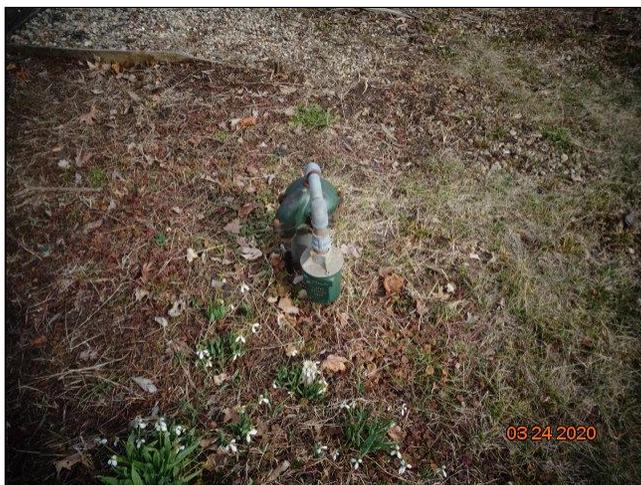
12.7 Item 1(Picture)

12.7 (1) Recommend a complete well and/or septic (septic pumped) inspection by qualified professional contractors prior to closing.

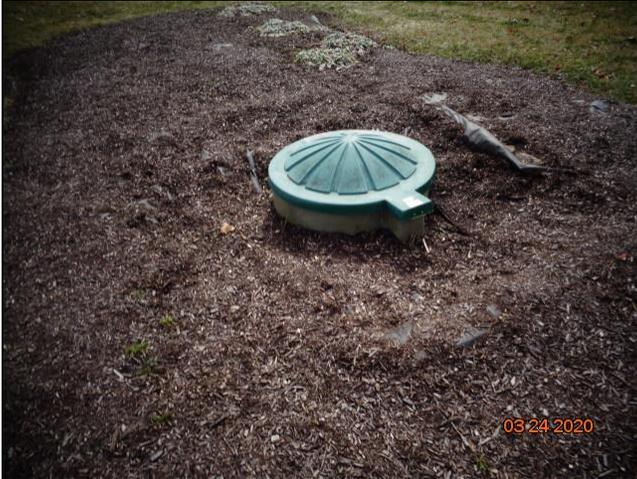
12.7 Item 2(Picture)

**12.7 (3)** A Multi-Flo Wastewater Treatment System is present, recommend further evaluation and inspection of system by a qualified/licensed plumber/contractor. Recommend inquiring with current owner regarding age of system, contractor (installer) contact information, if system has a current service contract, routine maintenance history of system, etc.

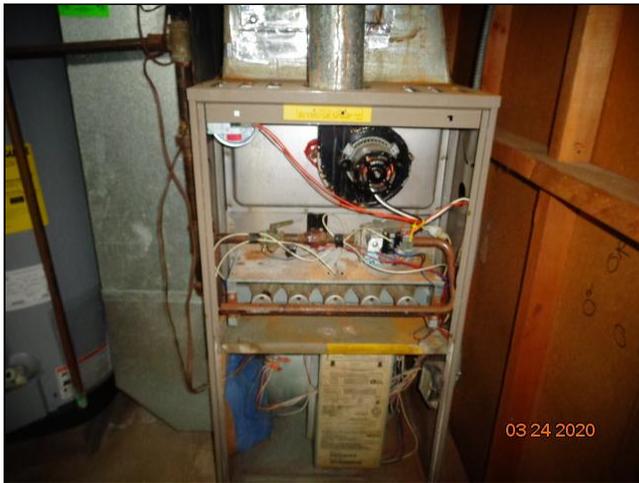
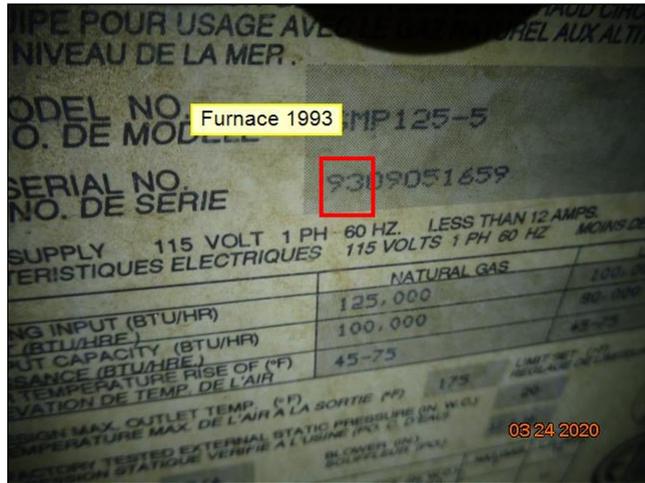
13.0 Item 1(Picture)

✘ 13.0 (1) Older 27 year old Furnace was present, budget for replacement in the very near future.

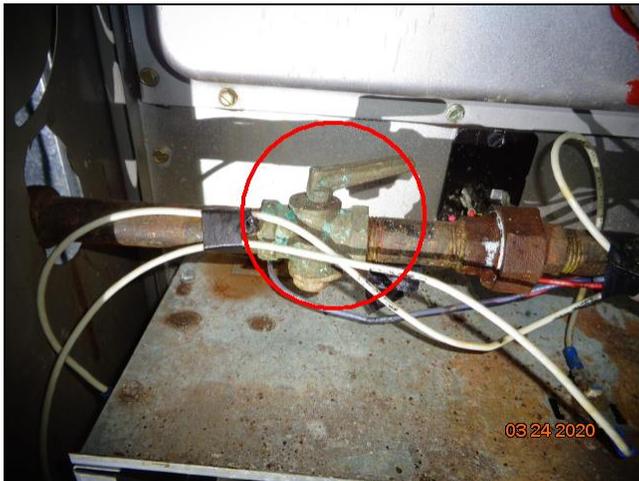
13.0 Item 3(Picture)

✘ 13.0 (2) Furnace gas shut off valve located within furnace is not a recommended practice, recommend proper repairs by a qualified/licensed professional HVAC contractor.

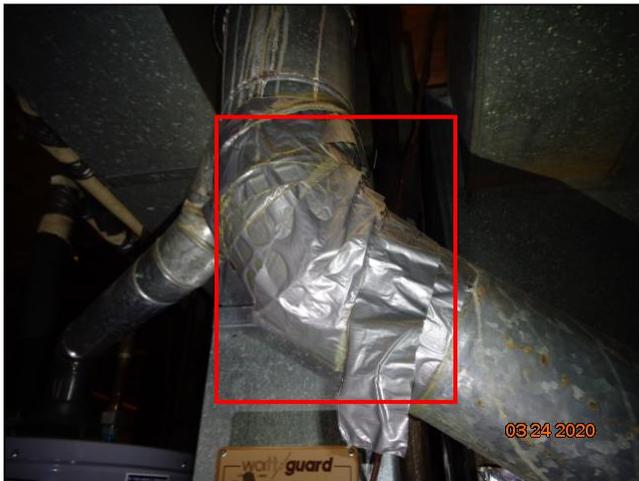
13.1 Item 1(Picture)

13.1 Furnace flue has duct-tape present, recommend proper repairs.

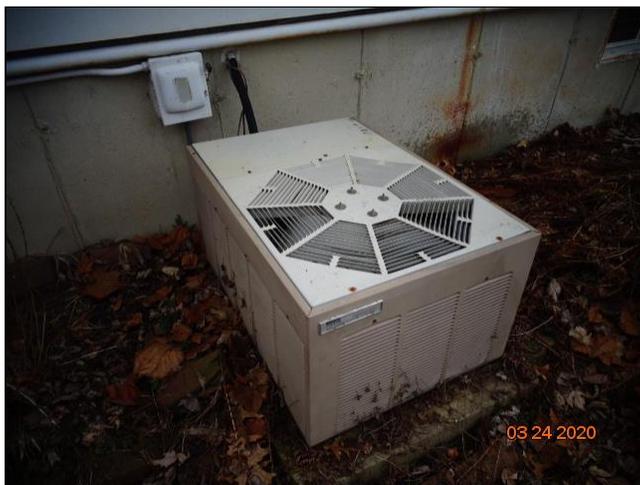
14.0 Item 1(Picture)

**14.0 (1) Older 41 year old A/C unit was present, budget for replacement in the very near future.**

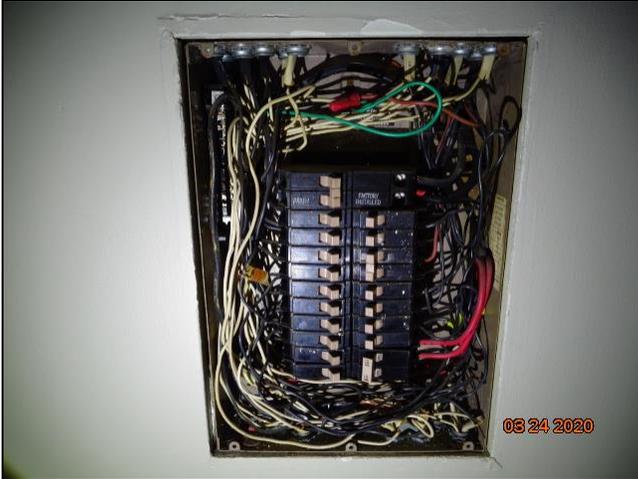
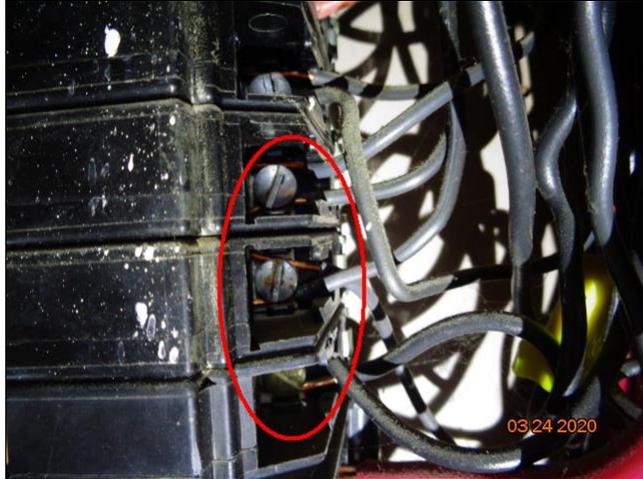
✘ 15.2 (1) Numerous (11) Double tapping is present at branch wiring breakers/fuses in main electrical panel; potential safety hazard, recommend proper repairs by a qualified/licensed professional electrician.

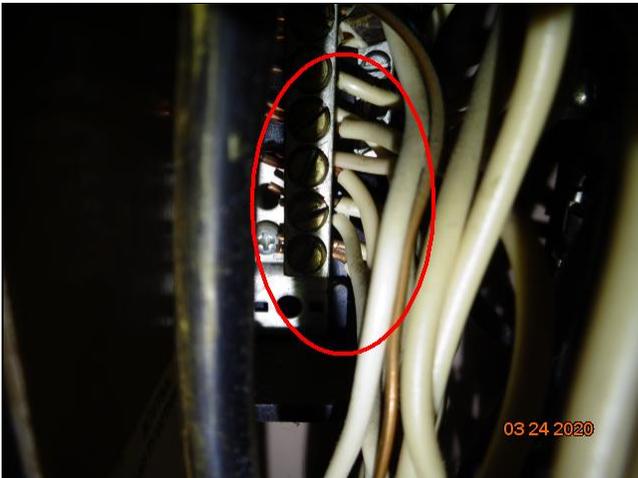
15.2 Item 4(Picture)

✘ 15.2 (2) Double tapping is present at neutral wires on bus bar in main electrical panel (which is no longer considered a common/proper practice); potential safety hazard, recommend ground and neutral wires are installed under individual screws, recommend proper repairs by a qualified/licensed professional electrician.

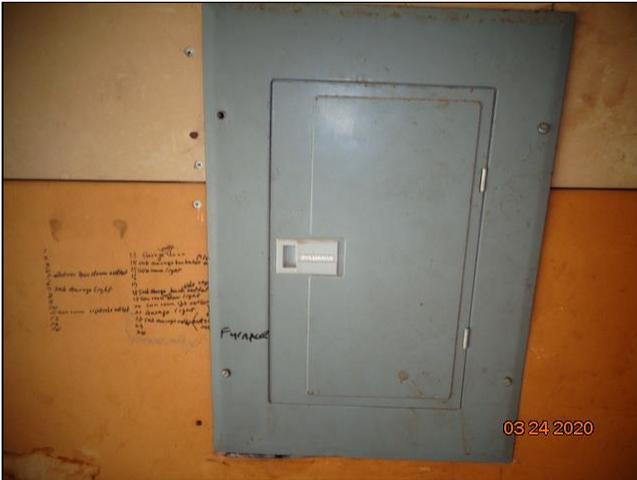
15.3 Item 1(Picture)

✘ 15.3 (1) The Sub Electrical Panel located in the Garage, is a GTE-Sylvania (manufactured by Zinsco/Challenger) electrical panel, which has a known history of being a problematic panel, which is well documented to be a fire/safety hazard, recommend further evaluation and proper repairs/panel replacement by a qualified/licensed professional electrician. For further information on these panels, please type GTE-Sylvania, Zinsco and/or Challenger electrical panels into an internet search engine.

NOTE: Some Professional Electricians may not be aware of the problematic history of the GTE-Sylvania electrical panel.

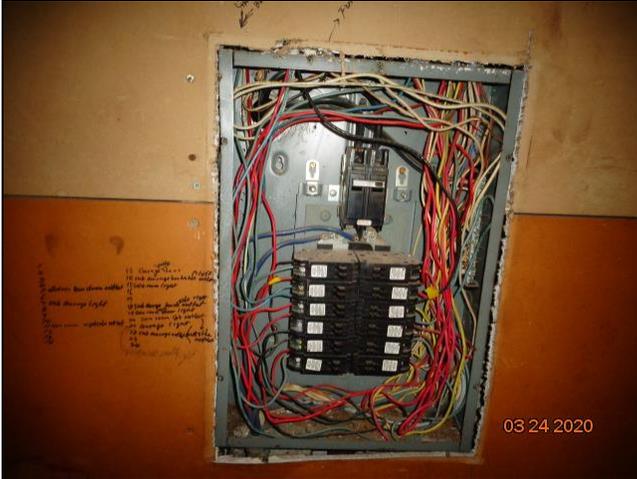
15.3 Item 4(Picture)

✗ 15.3 (2) Recommend grounds and neutral wires are separated/isolated in sub-panel, recommend further evaluation and proper repairs by a qualified/licensed professional electrician.

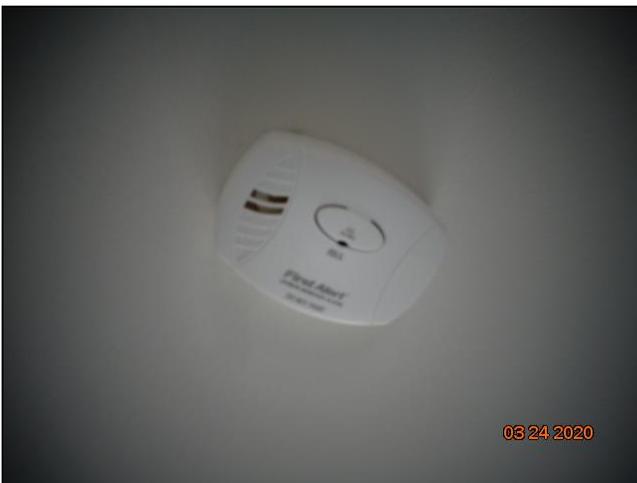
15.6 Item 1(Picture)

15.6 (1) Carbon monoxide detector(s) were present at time of inspection.

15.6 (2) Recommend carbon monoxide detectors are installed within 15' of rooms being used for sleeping purposes per Illinois state law, effective January 1, 2007.

15.6 (3) Recommend a carbon monoxide detector on each level of the home.

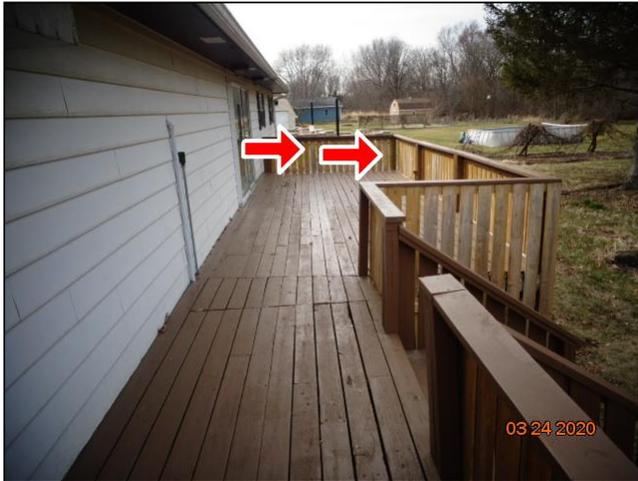
1.3 Item 1(Picture)

- (1) Deck was in overall marginal to poor condition, recommend proper repairs/replacement.
- (2) Deck structure was not level/square, recommend proper repairs.

(8) Recommend further evaluation and proper repairs by a qualified professional Deck contractor.

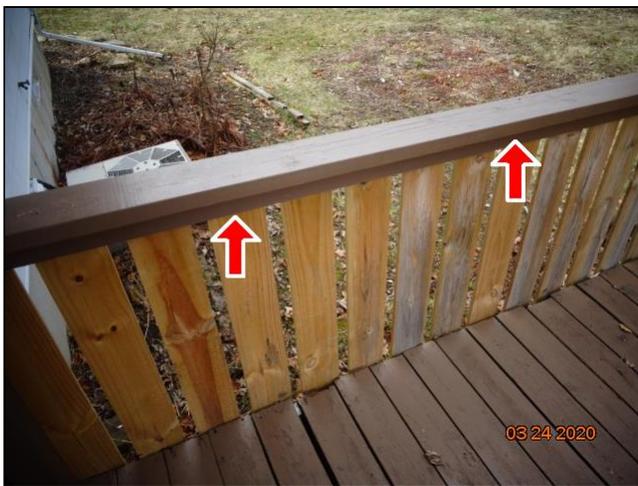
1.3 Item 2(Picture)

❌ (3) Deck railings were loose and need to be secured; potential safety hazard, recommend proper repairs.

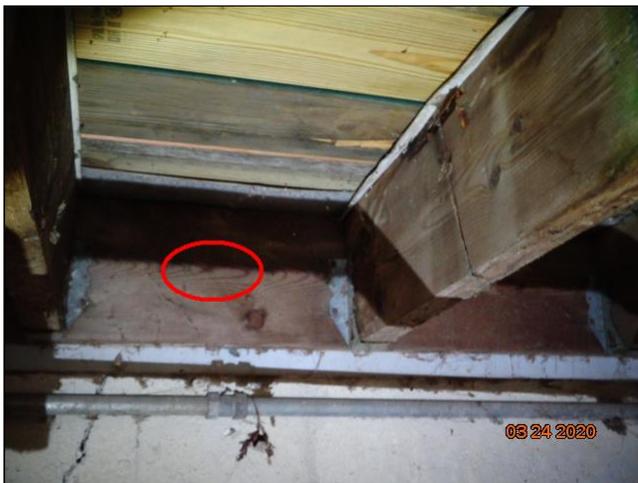
1.3 Item 4(Picture)

❌ (4) Deck (ledger board) is not attached to the house properly, recommend lag bolts are installed to properly secure the Deck, recommend proper repairs.

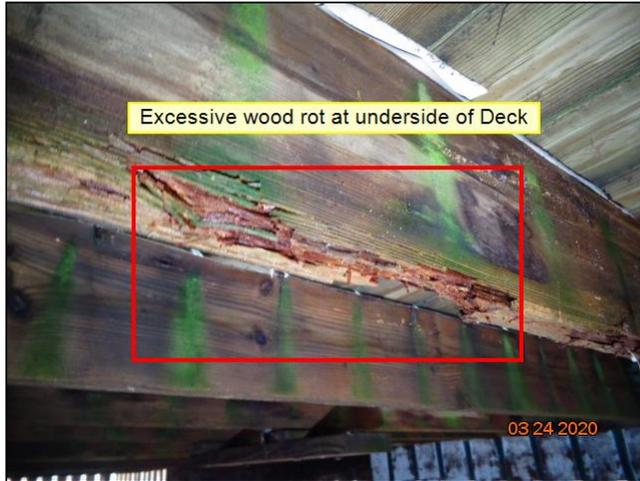
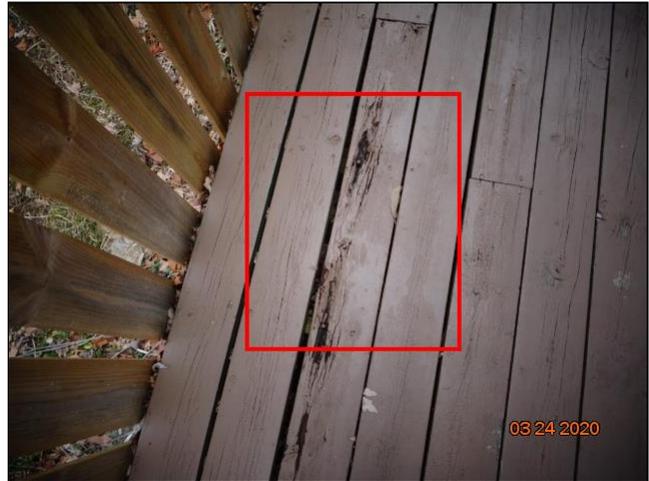
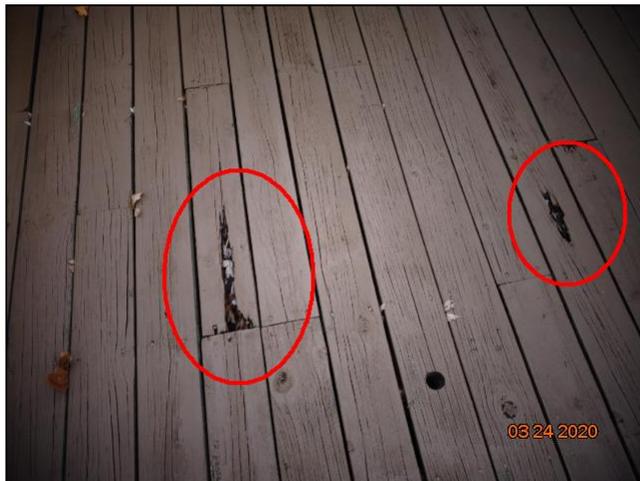
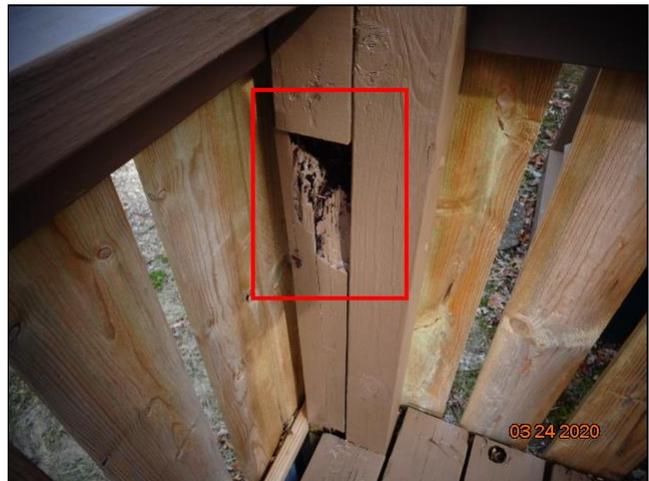
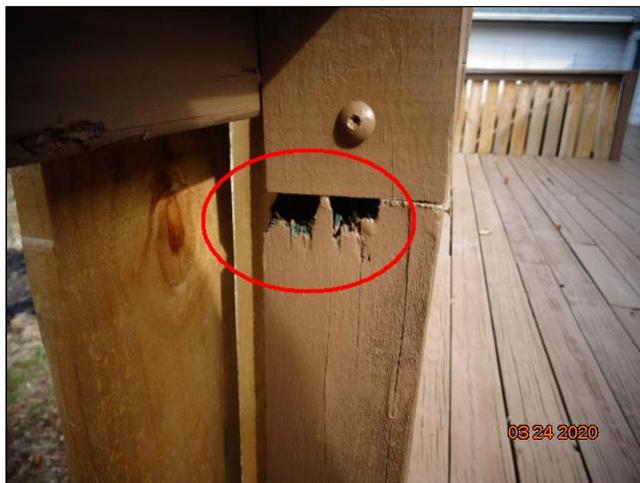
❌ (5) Deck boards/framing have wood rot present, recommend proper repairs.

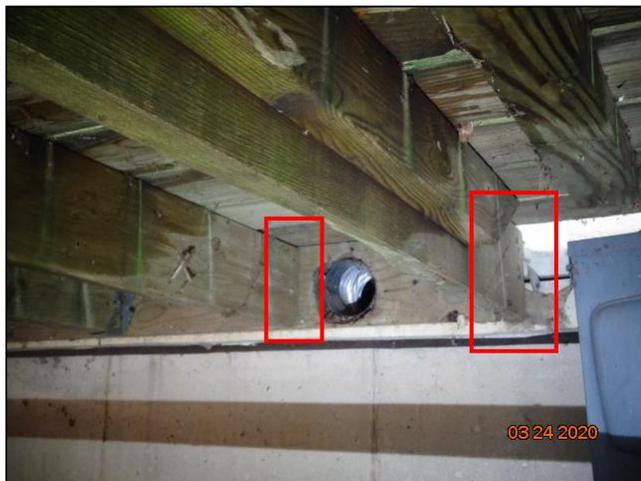
1.3 Item 10(Picture)

(6) Joist hangers are not installed at Deck, recommend proper repairs.

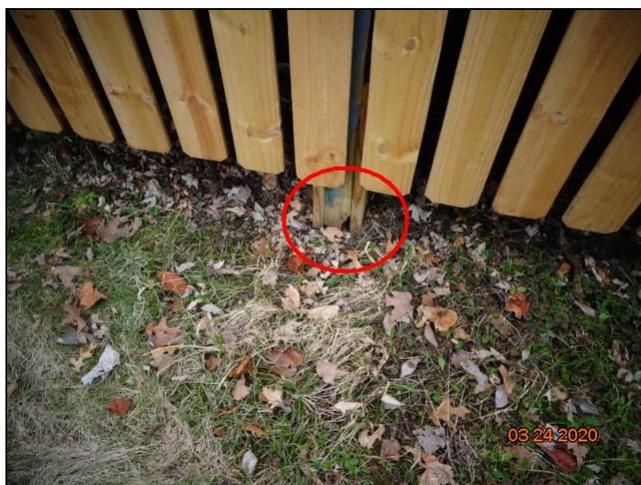
1.3 Item 11(Picture)

(7) Deck support columns in direct contact with soil/grading is not a recommended practice, repair as needed.

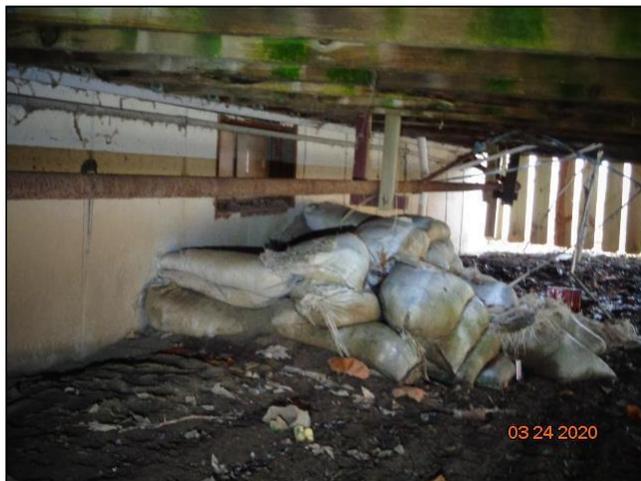
1.4 Item 1(Picture)

(1) A number of sand bags have been installed at north Basement window, recommend inquiring with current owner regarding past flooding issues within the home/yard/property. (Note: Wetland area/creek is present directly behind the home).

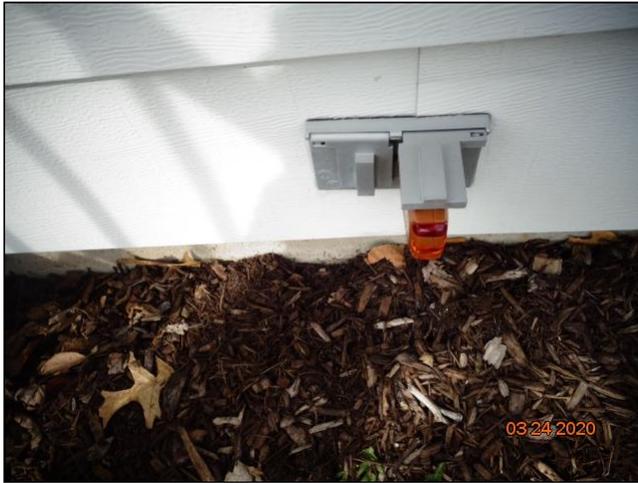
3.8 Item 2(Picture)

(2) Exterior outlet(s) present with open grounds; potential safety hazard, recommend proper repairs by a qualified/licensed professional electrician.

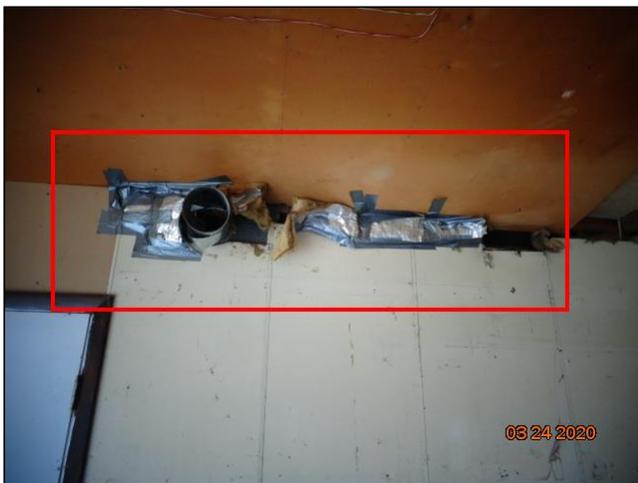
4.1 Item 1(Picture)

- Firewall (fire-rated drywall, 5/8"/Type X) between Garage and House wall is not present; potential safety hazard, recommend proper repairs.

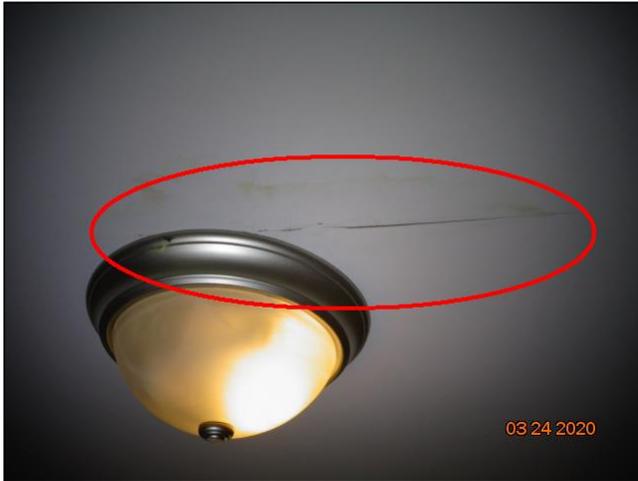
8.1 Item 1(Picture)

(1) Staining/water marks were present on ceiling area of North Bedroom, recommend further evaluation and proper repairs.

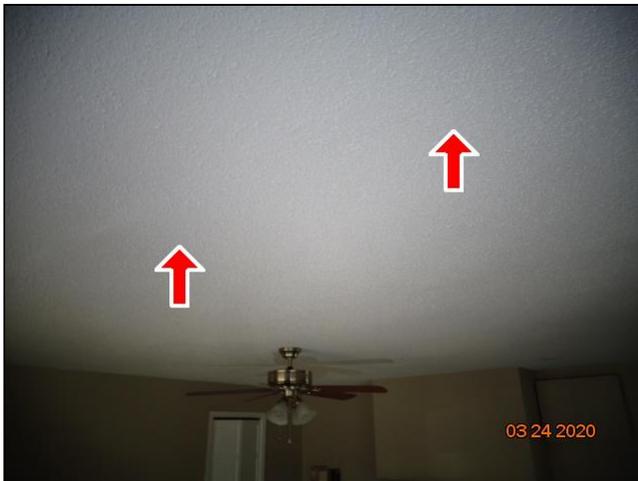
8.1 Item 2(Picture)

(2) Textured/"Popcorn" ceilings were present in the home, which may possibly contain an asbestos like material, recommend further evaluation/testing by a qualified contractor as needed.

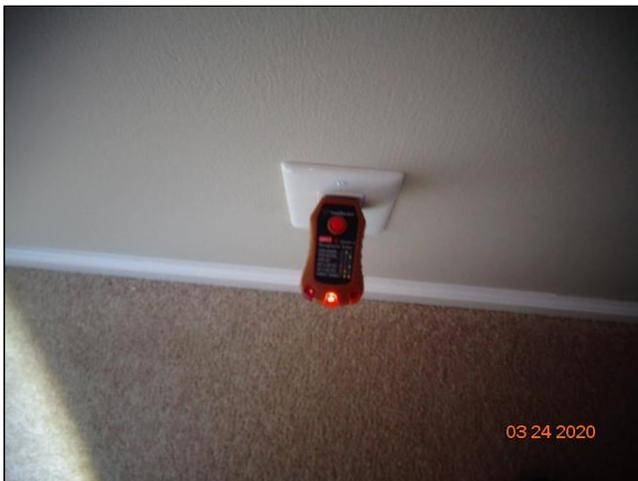
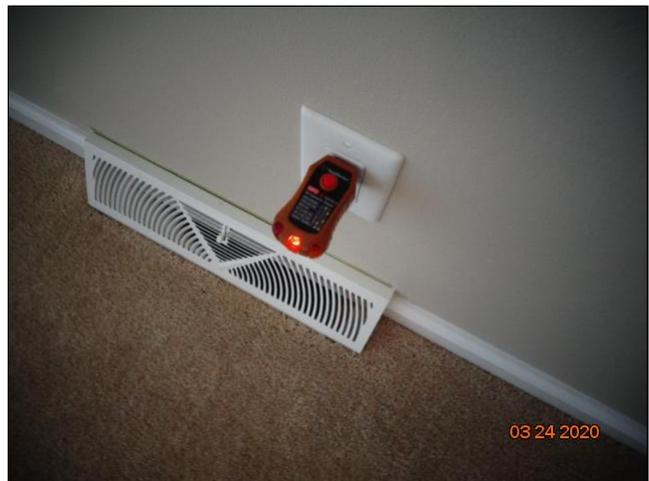
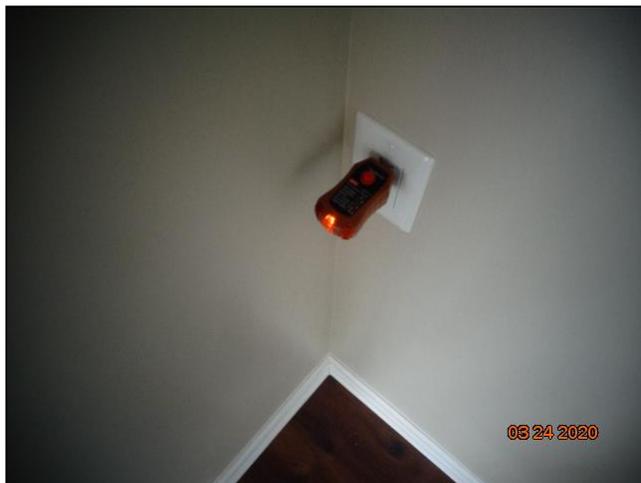
The majority of the three prong outlets are not properly grounded, recommend proper repairs by a qualified/licensed professional electrician.

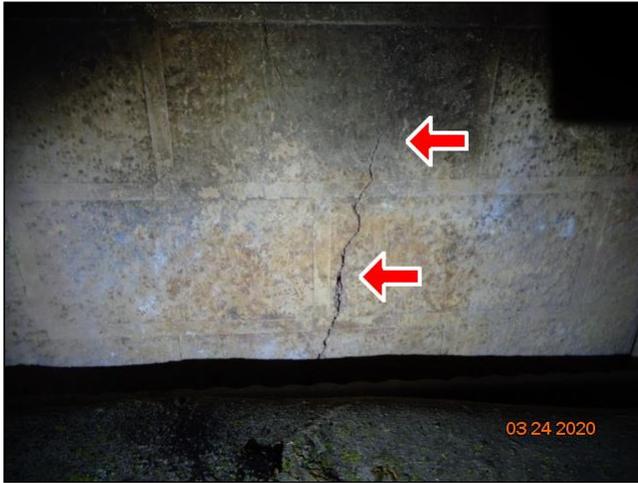
9.0 Item 1(Picture)

(1) Fireplace box has cracked refractory panel(s) present, potential safety hazard(s), recommend further evaluation and replacement panels and/or sealing of cracks by a qualified professional fireplace/chimney contractor.

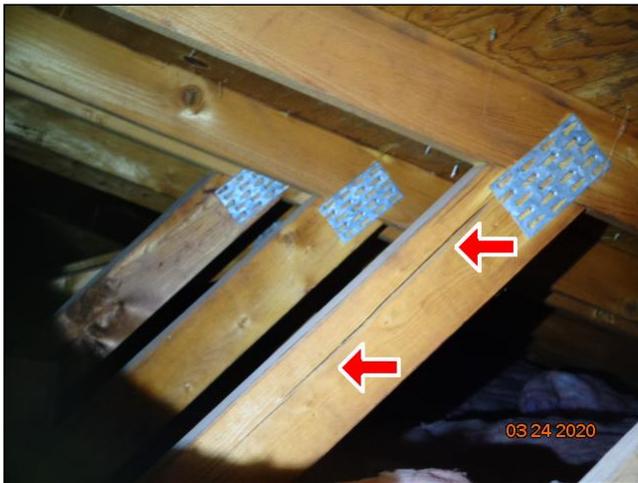
10.1 Item 1(Picture)

(1) Cracked/damaged truss was present in main attic area, recommend proper repairs.

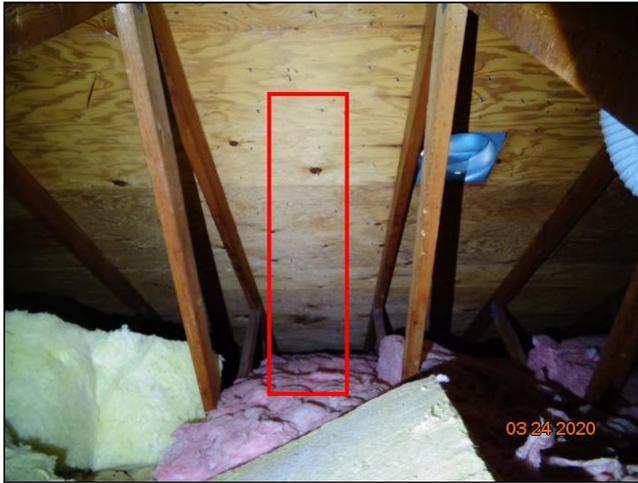
10.3 Item 1(Picture)

(2) Recommend air baffles/channel vents are installed at soffit vents for additional ventilation, recommend proper repairs.

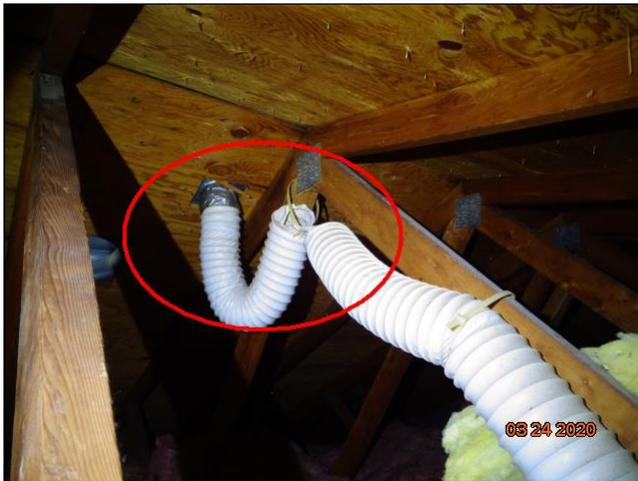
10.4 Item 1(Picture)

Recommended extending exhaust fans venting to the exterior to dedicated discharge(s), recommend proper repairs.

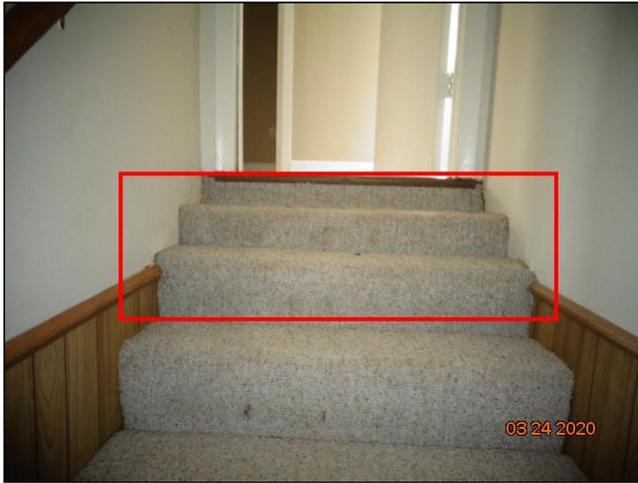
11.0 Item 1(Picture)

Basement staircase has uneven riser heights present, potential safety/trip hazards present, recommend proper repairs.

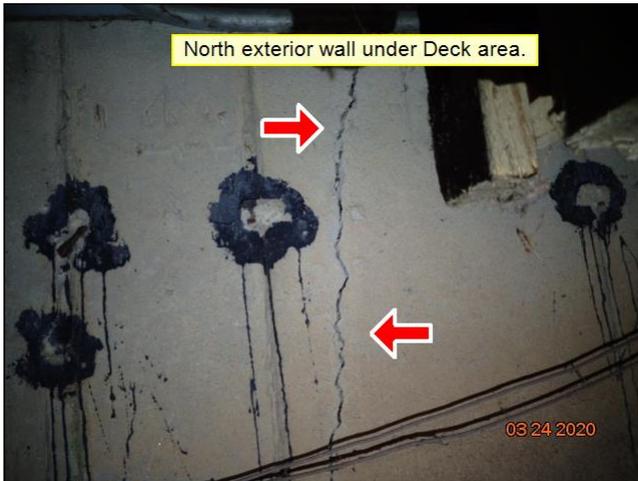
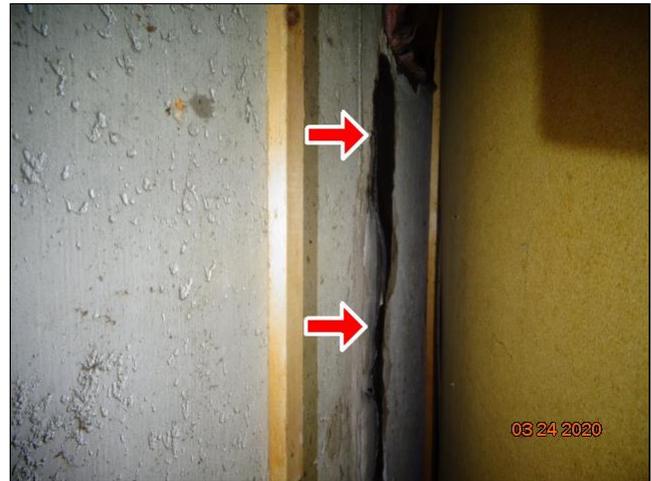
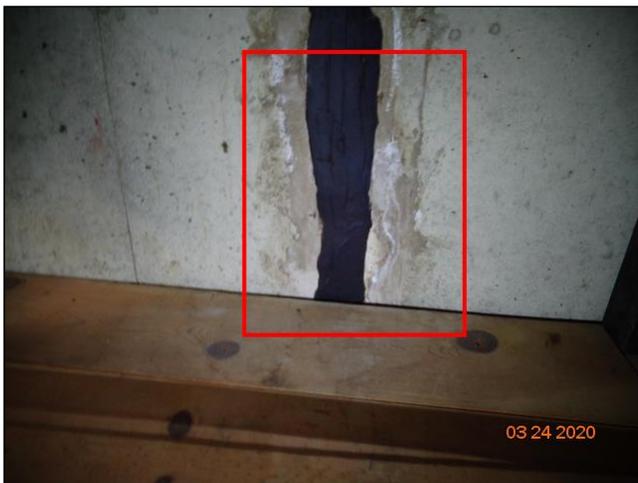
(1) Foundation wall shows evidence of cracking/movement and are in need of additional patching/repairs, recommend further evaluation and proper repairs by a qualified professional foundation contractor.
