Inspection Report

Property Address:
1234 Main Street
Anytown IL 60554

Quality Assurance Home Inspections, Inc.

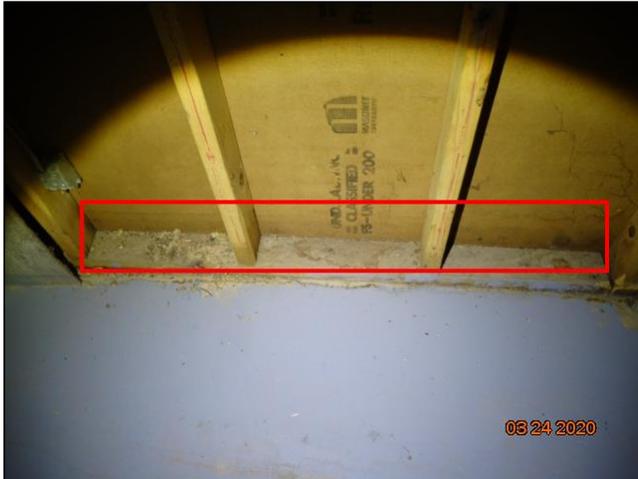
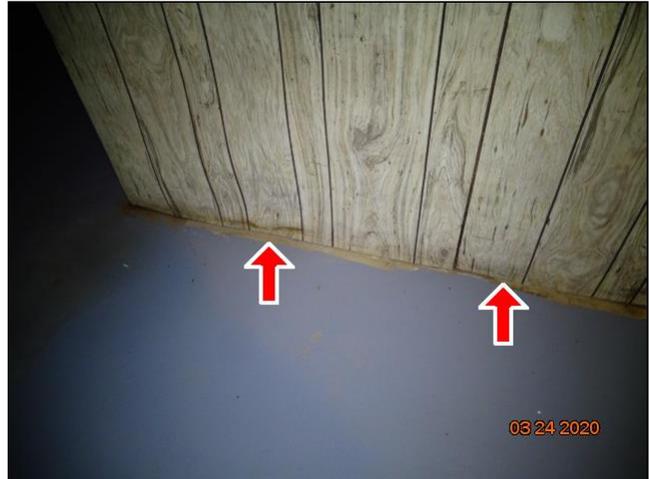
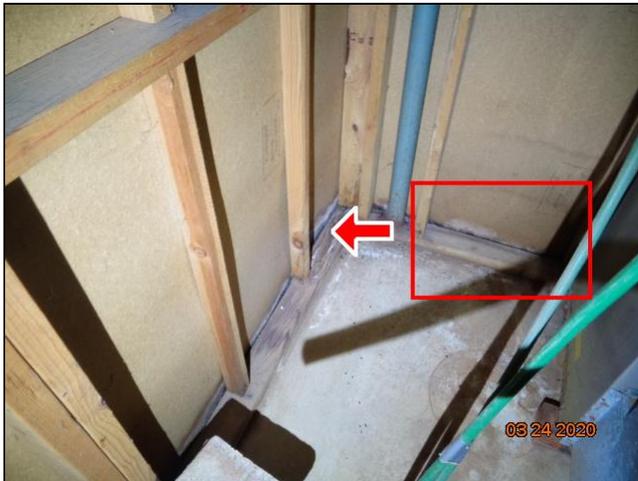
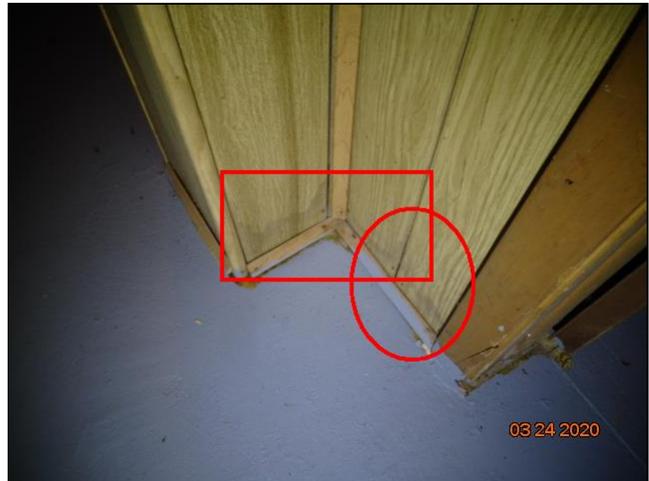
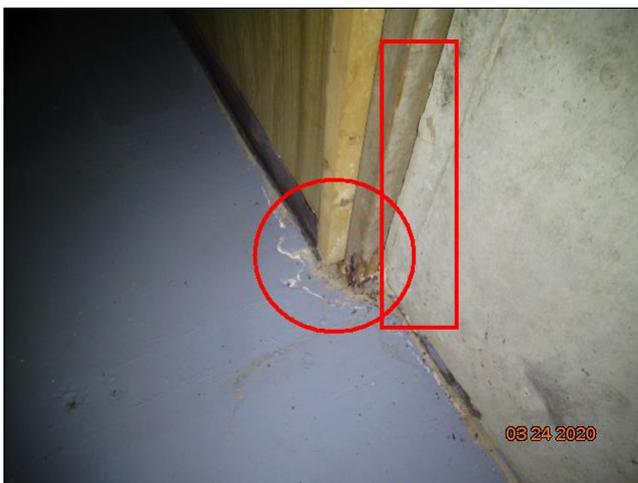
- ❌ (2) Evidence of water intrusion is apparent in Basement area (water lines present in a number of areas throughout the Basement), recommend inquiring with current owner (and obtaining property disclosures) regarding past water issues/intrusion in Basement area, recommend further evaluation and proper repairs.

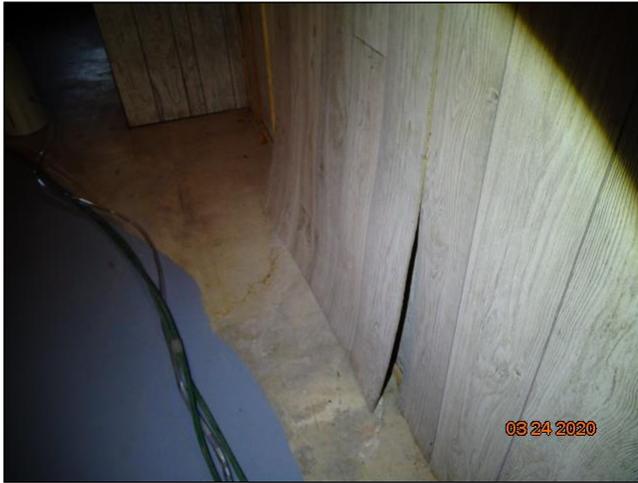
11.1 Item 9(Picture)

- ❌ (3) Evidence of previous seepage/water intrusion was present, maintain a positive drainage slope away from the foundation, recommend patching as needed.
- ❌ (4) Paneling was warped in a number of areas, from water intrusion, recommend proper repairs.

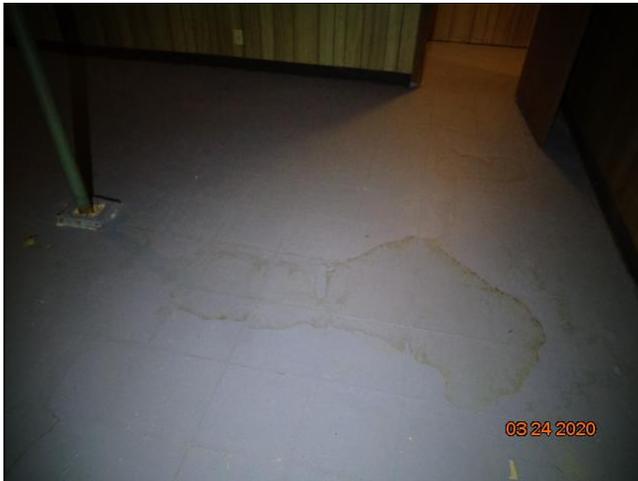
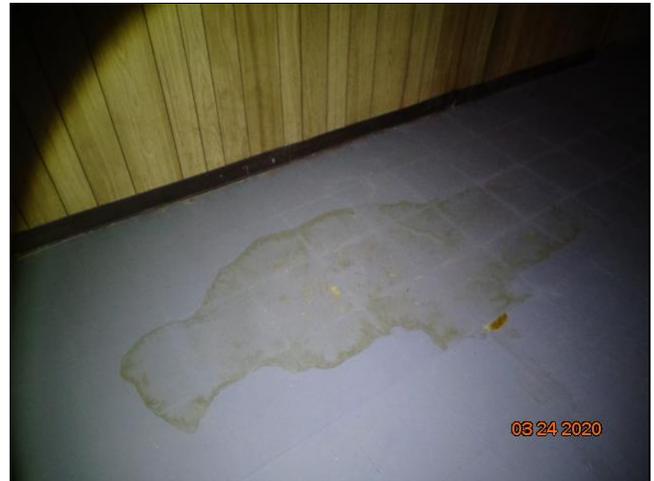
- (1) Evidence of water intrusion is apparent in Basement area. recommend inquiring with current owner (and obtaining property disclosures) regarding past water issues/intrusion in Basement area, recommend further evaluation and proper repairs.

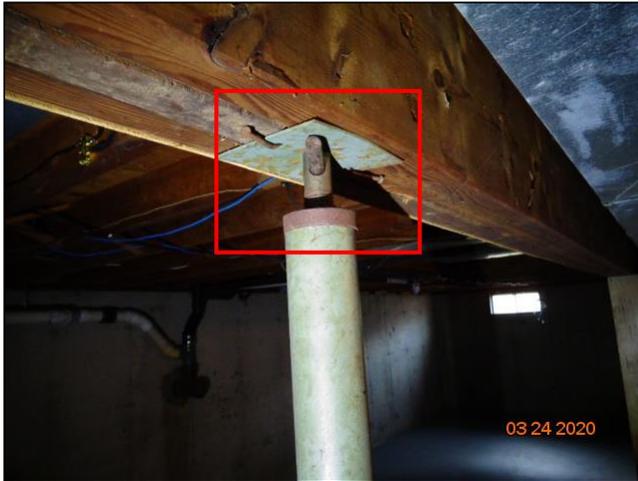
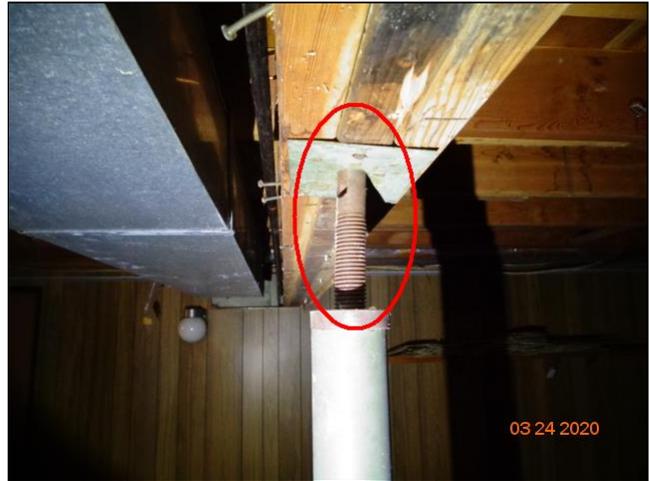
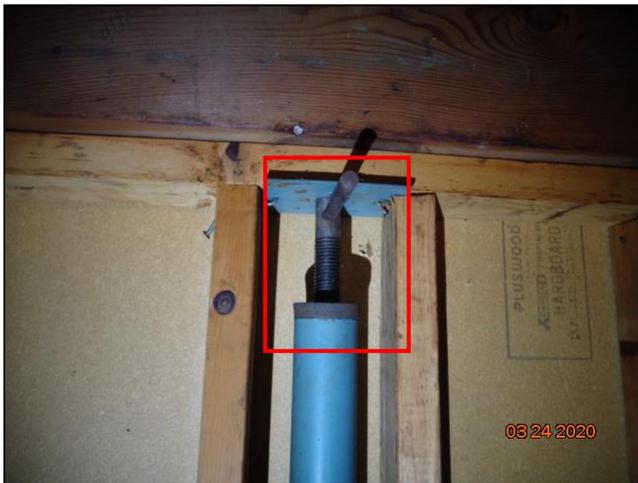
- Telescopic screw floor jacks (no longer a recommended practice) have been installed as permanent support columns for main load bearing support girder, recommend proper support columns are installed (e.g. solid 3" support columns, top plate, bottom plates are properly installed/secured), recommend proper repairs by a qualified/licensed professional contractor.

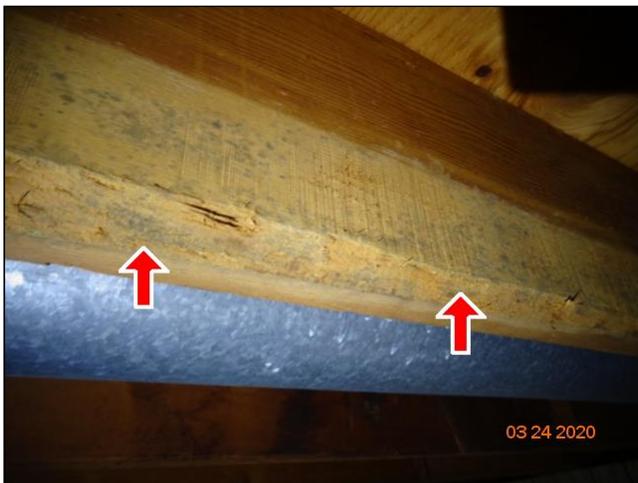
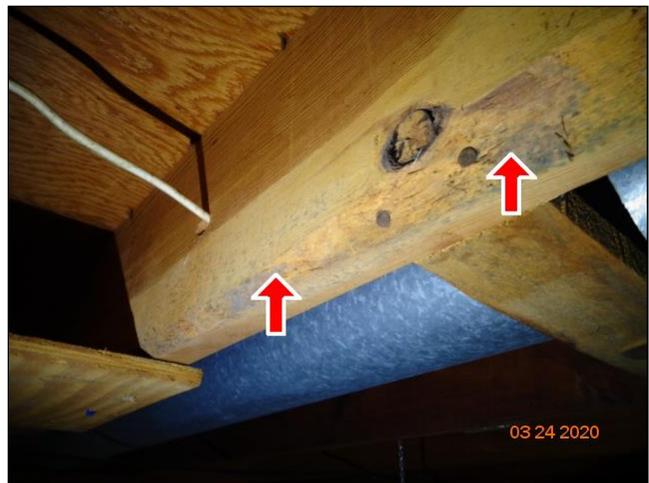
(1) Evidence of microbial growth; a mold/mildew/fungi like substance was visible at time of inspection in Basement area on floor joists; potential safety hazards, recommend further evaluation (air testing/tape lifts) and proper repairs (remediation) by qualified/certified/experienced/reputable professional mold contractors.

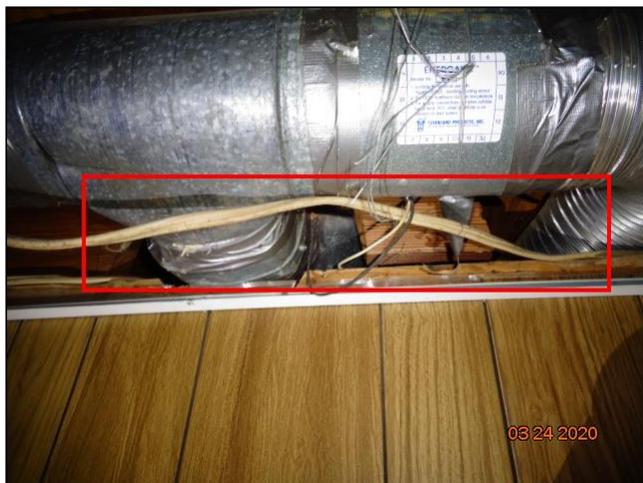
11.5 Item 3(Picture)

❌ (2) Floor joist(s) has been improperly cut/notched, recommend proper repairs/re-supporting.

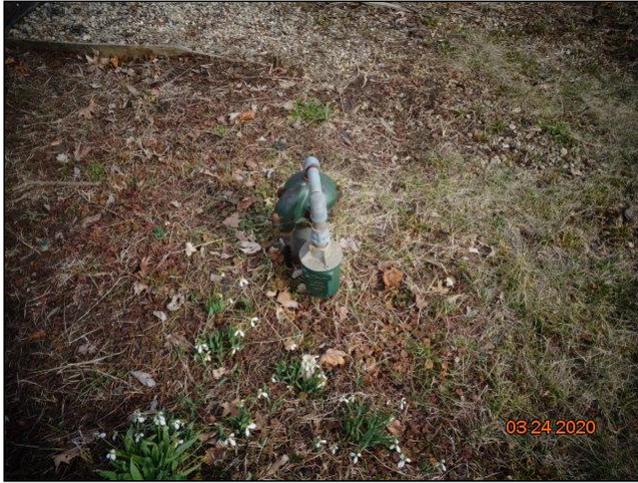
12.7 Item 1(Picture)

(1) Recommend a complete well and/or septic (septic pumped) inspection by qualified professional contractors prior to closing.

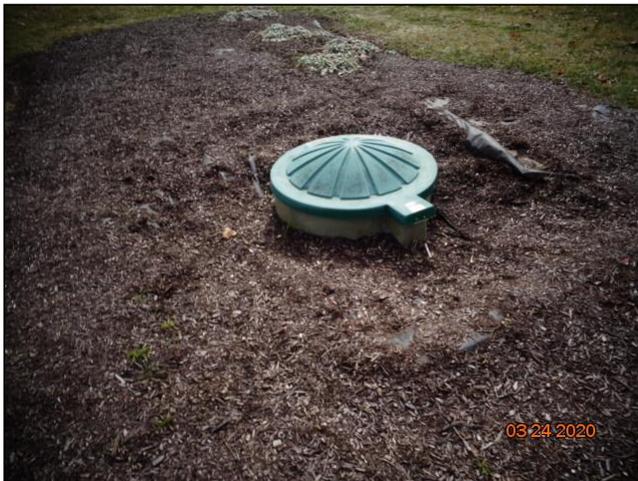
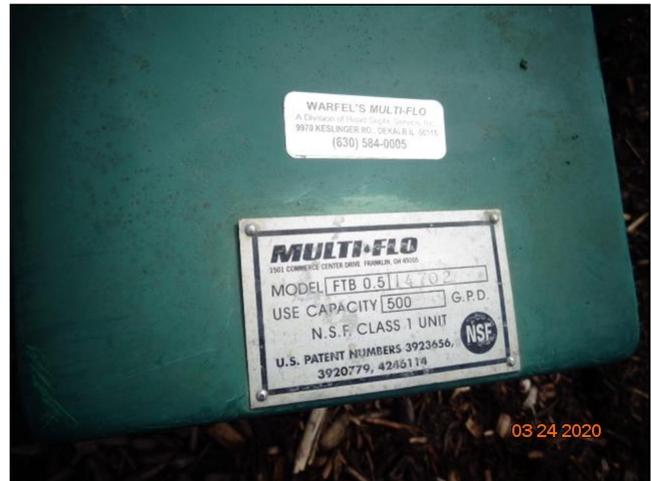
(3) A Multi-Flo Wastewater Treatment System is present, recommend further evaluation and inspection of system by a qualified/licensed plumber/contractor. Recommend inquiring with current owner regarding age of system, contractor (installer) contact information, if system has a current service contract, routine maintenance history of system, etc.

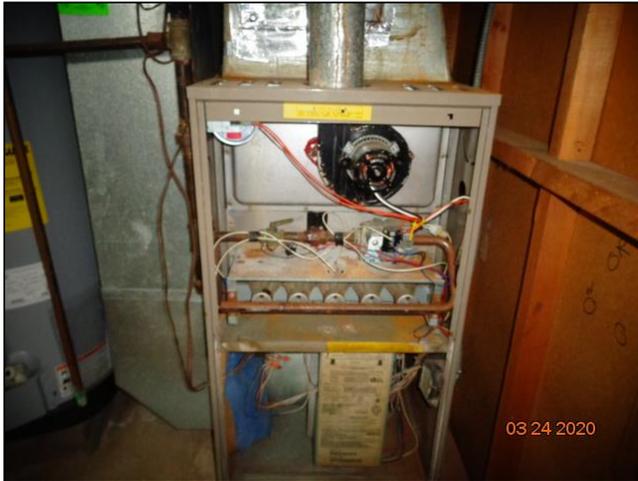
13.0 Item 1(Picture)

(1) Older 27 year old Furnace was present, budget for replacement in the very near future.

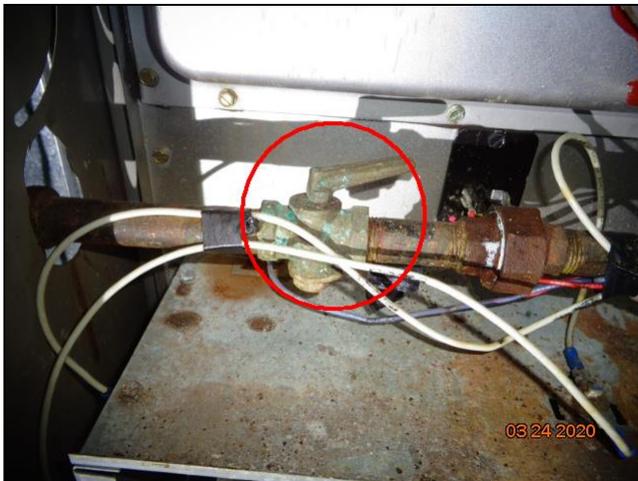
13.0 Item 3(Picture)

(2) Furnace gas shut off valve located within furnace is not a recommended practice, recommend proper repairs by a qualified/licensed professional HVAC contractor.

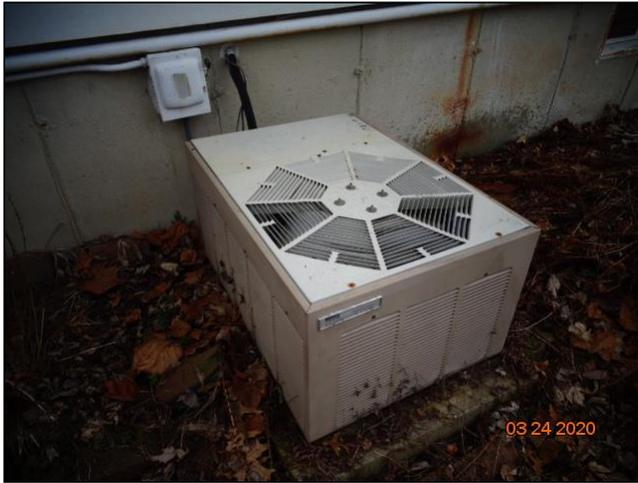
14.0 Item 1(Picture)

(1) Older 41 year old A/C unit was present, budget for replacement in the very near future.

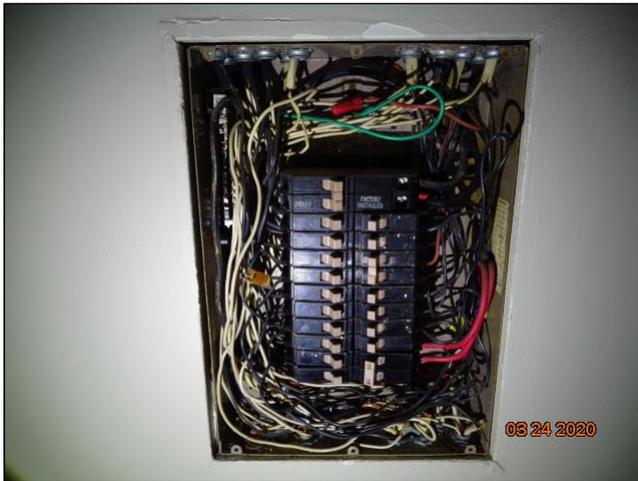
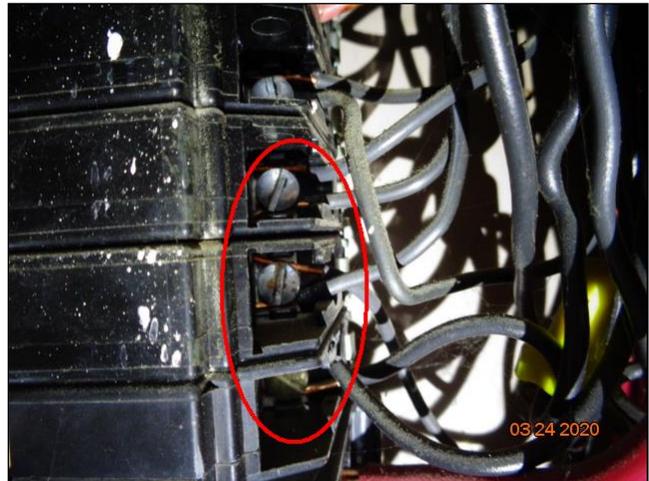
- ❌ (1) Numerous (11) Double tapping is present at branch wiring breakers/fuses in main electrical panel; potential safety hazard, recommend proper repairs by a qualified/licensed professional electrician.

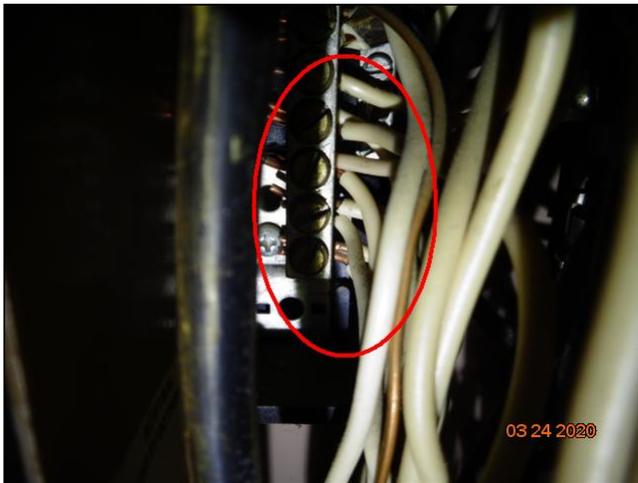
15.2 Item 4(Picture)

(2) Double tapping is present at neutral wires on bus bar in main electrical panel (which is no longer considered a common/proper practice); potential safety hazard, recommend ground and neutral wires are installed under individual screws, recommend proper repairs by a qualified/licensed professional electrician.

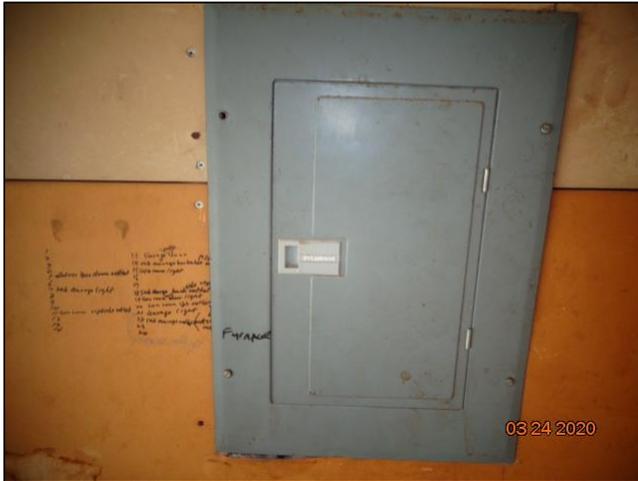
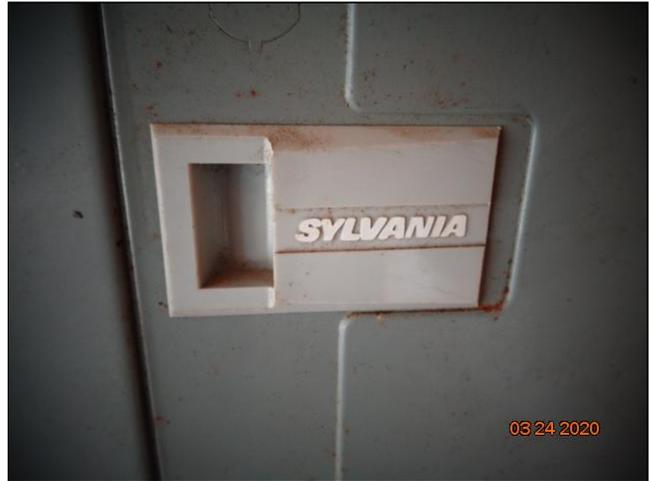
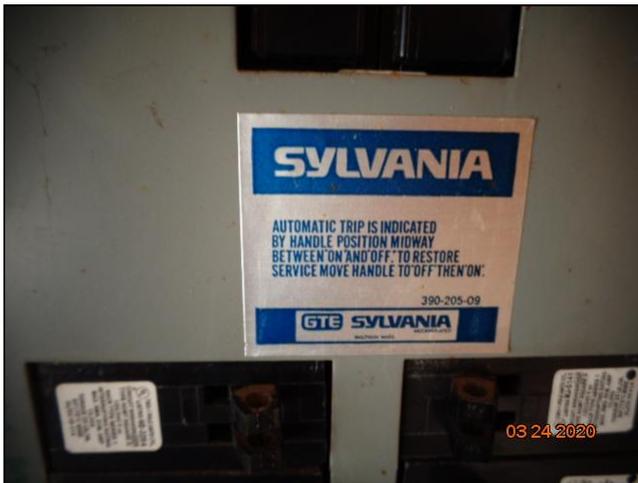
(1) The Sub Electrical Panel located in the Garage, is a GTE-Sylvania (manufactured by Zinsco/Challenger) electrical panel, which has a known history of being a problematic panel, which is well documented to be a fire/safety hazard, recommend further evaluation and proper repairs/panel replacement by a qualified/licensed professional electrician. For further information on these panels, please type GTE-Sylvania, Zinsco and/or Challenger electrical panels into an internet search engine.

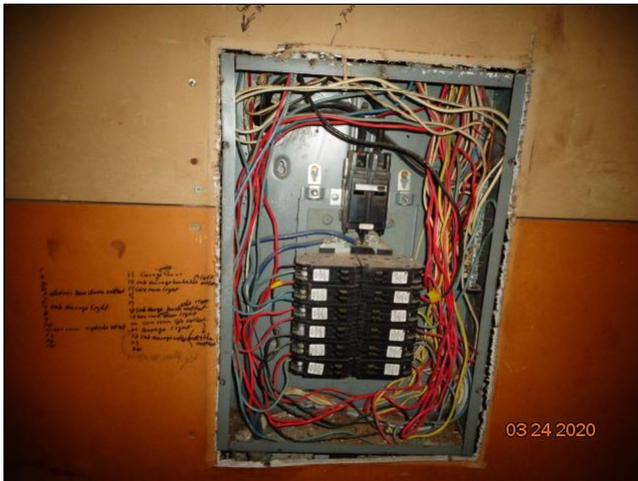
15.3 Item 4(Picture)

(2) Recommend grounds and neutral wires are separated/isolated in sub-panel, recommend further evaluation and proper repairs by a qualified/licensed professional electrician.
